# **Geomorphic Reclamation in New Mexico: A Regulator's Perspective**

**Dave Clark**

**NM Mining and Minerals Division**

**AUG 28 2008**

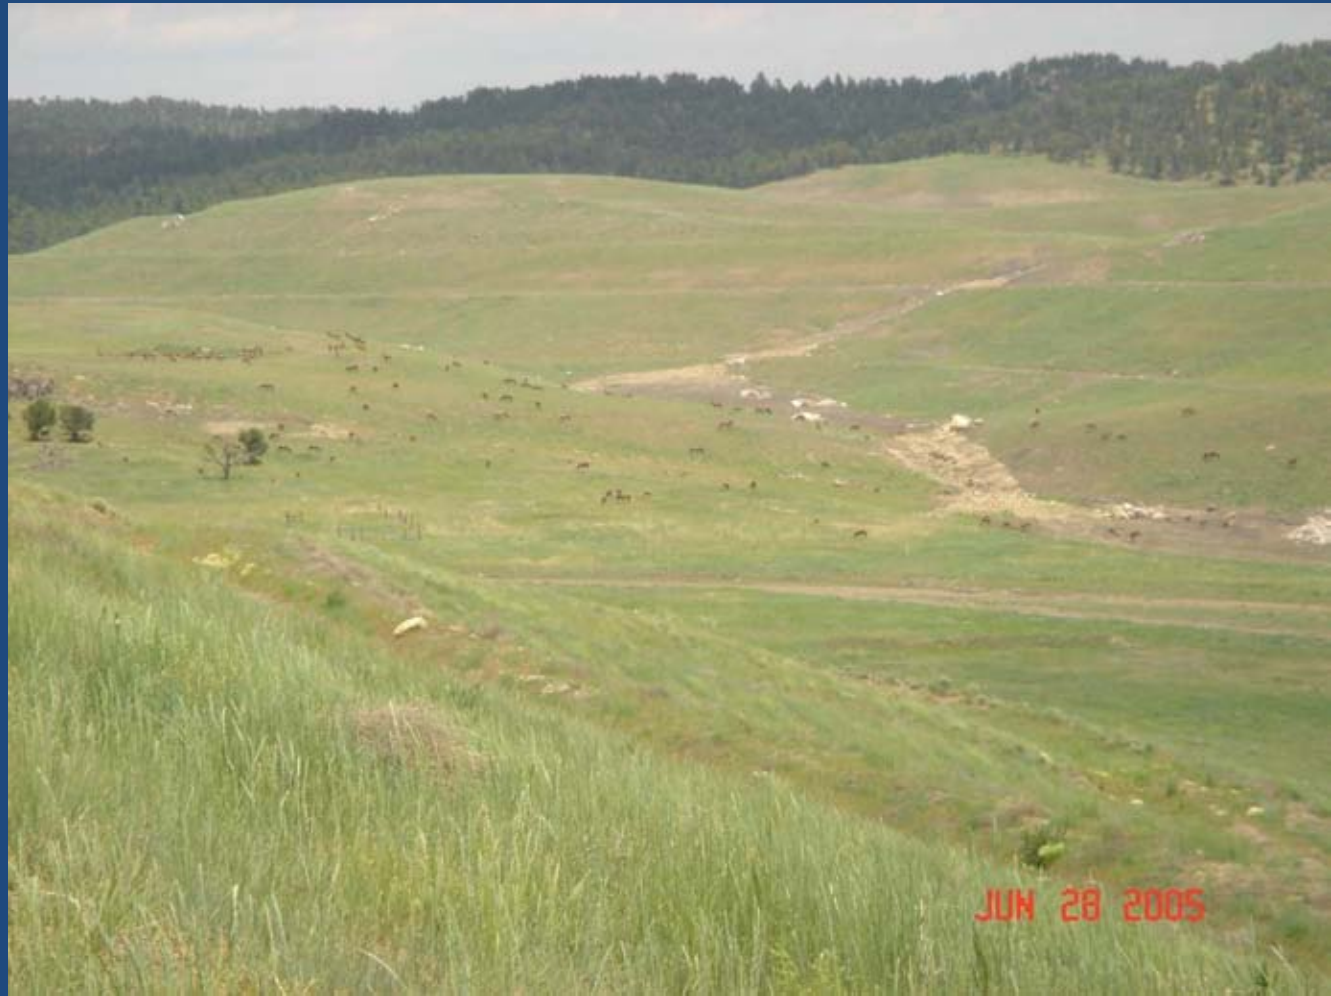
Conventional steep slope construction is typified by low gradient terraces that convey runoff across a slope to a rock-armored drop structure that has been designed to pass a specific event. On coal mines, this is typically the local 10-year / 24-hour precipitation event.

Storms that are smaller or larger than the design event cause problems, either by sediment deposition or erosion.

Differential settling may also be a problem.

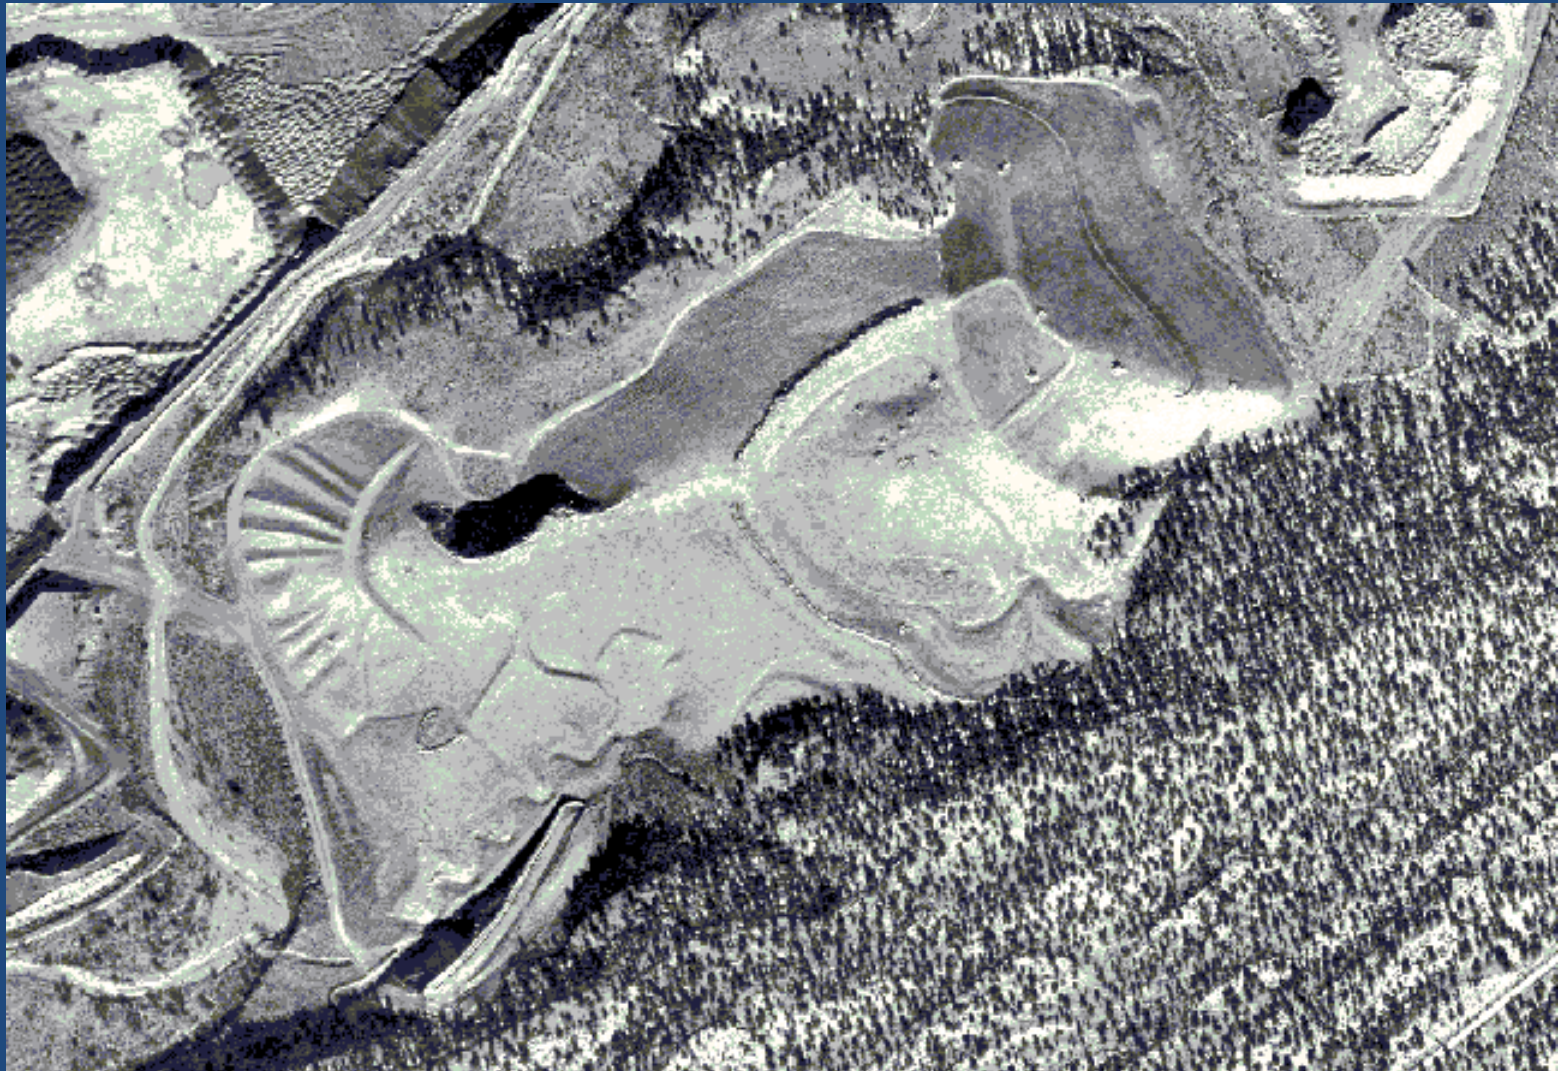
# McDermott Dump 52-ac “proving ground”

- Geomorphic drainages
- Scallop slope
- Talus slope
- Rock rims
- Suitable spoil
- Rock mulch
- Multiple seed mixtures
- Wildlife pond

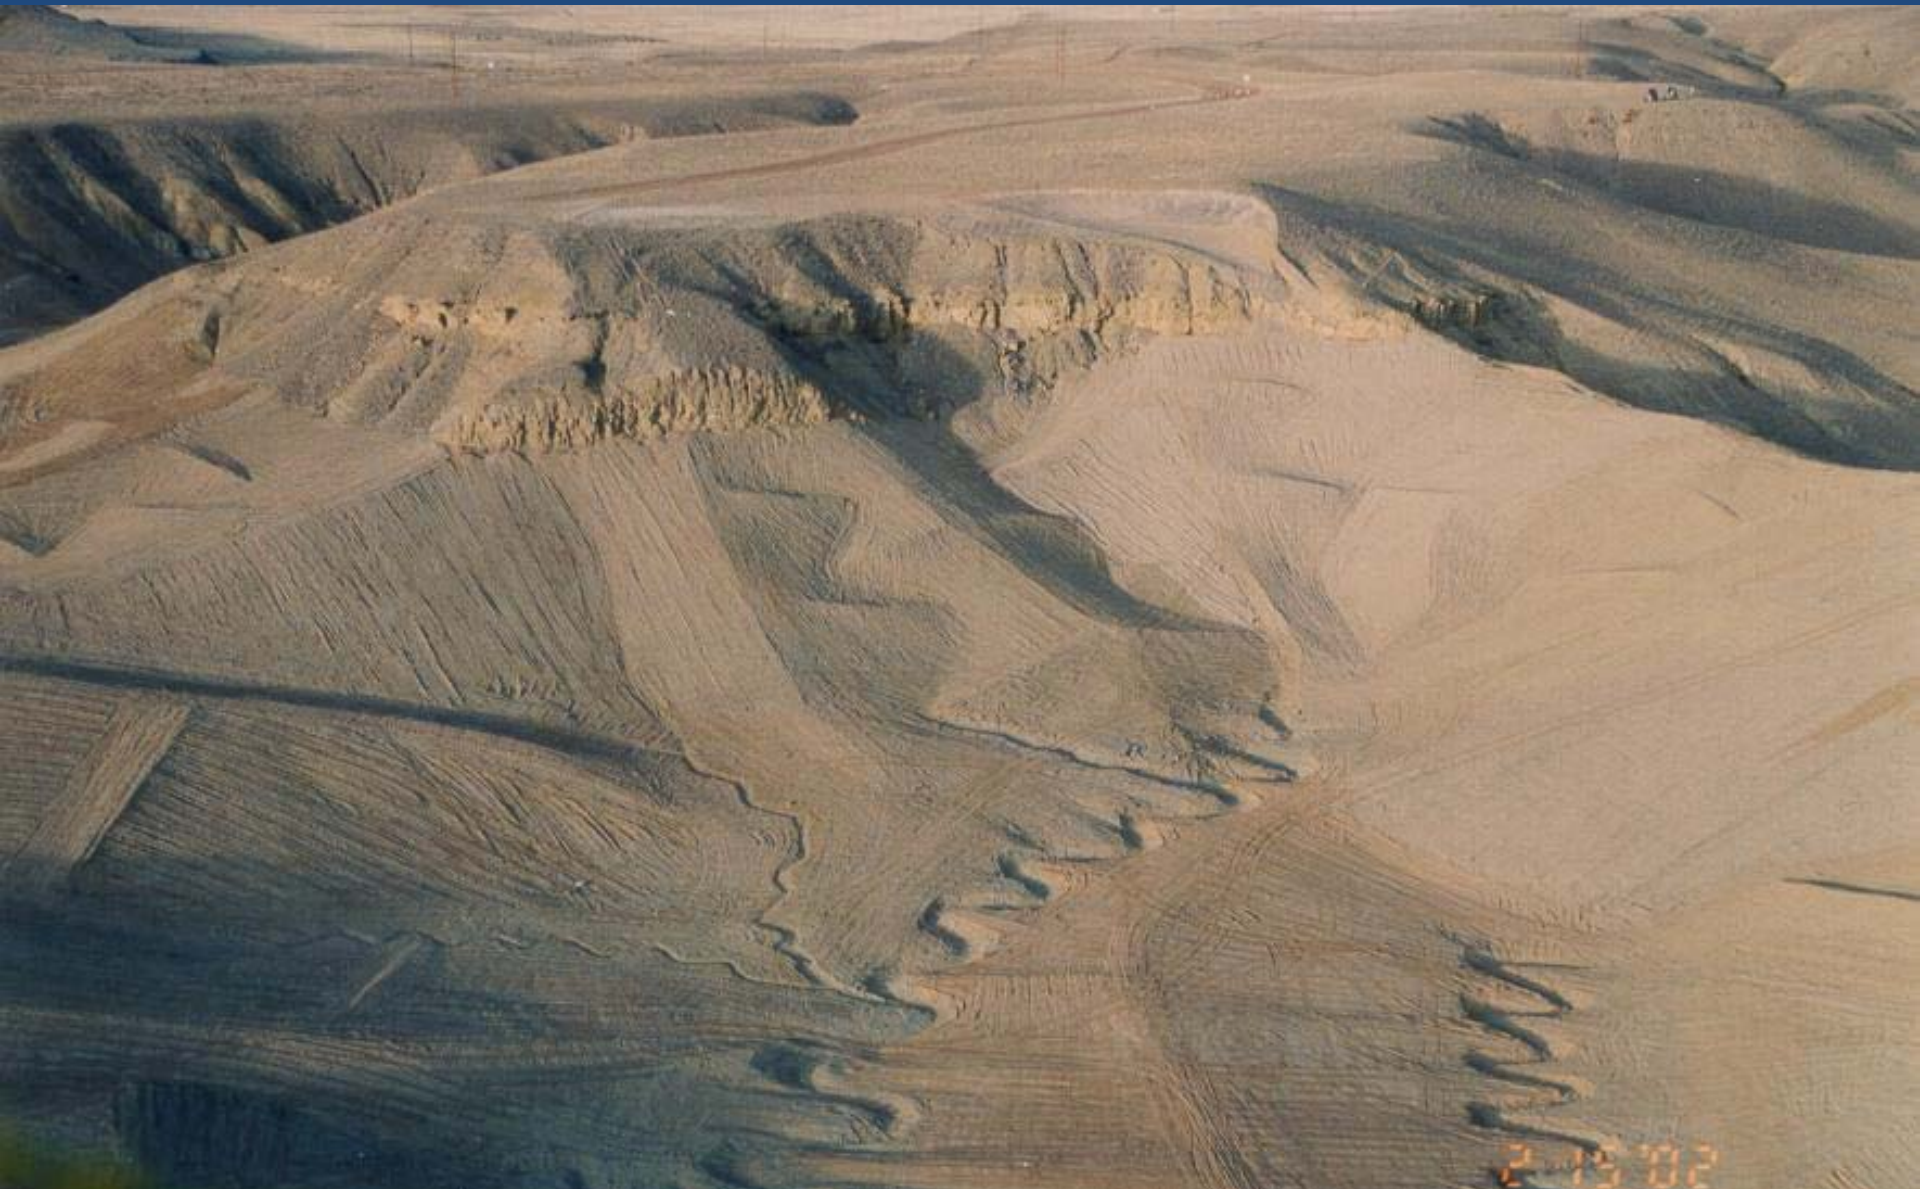
# Cottonwood Pit end wall regrade

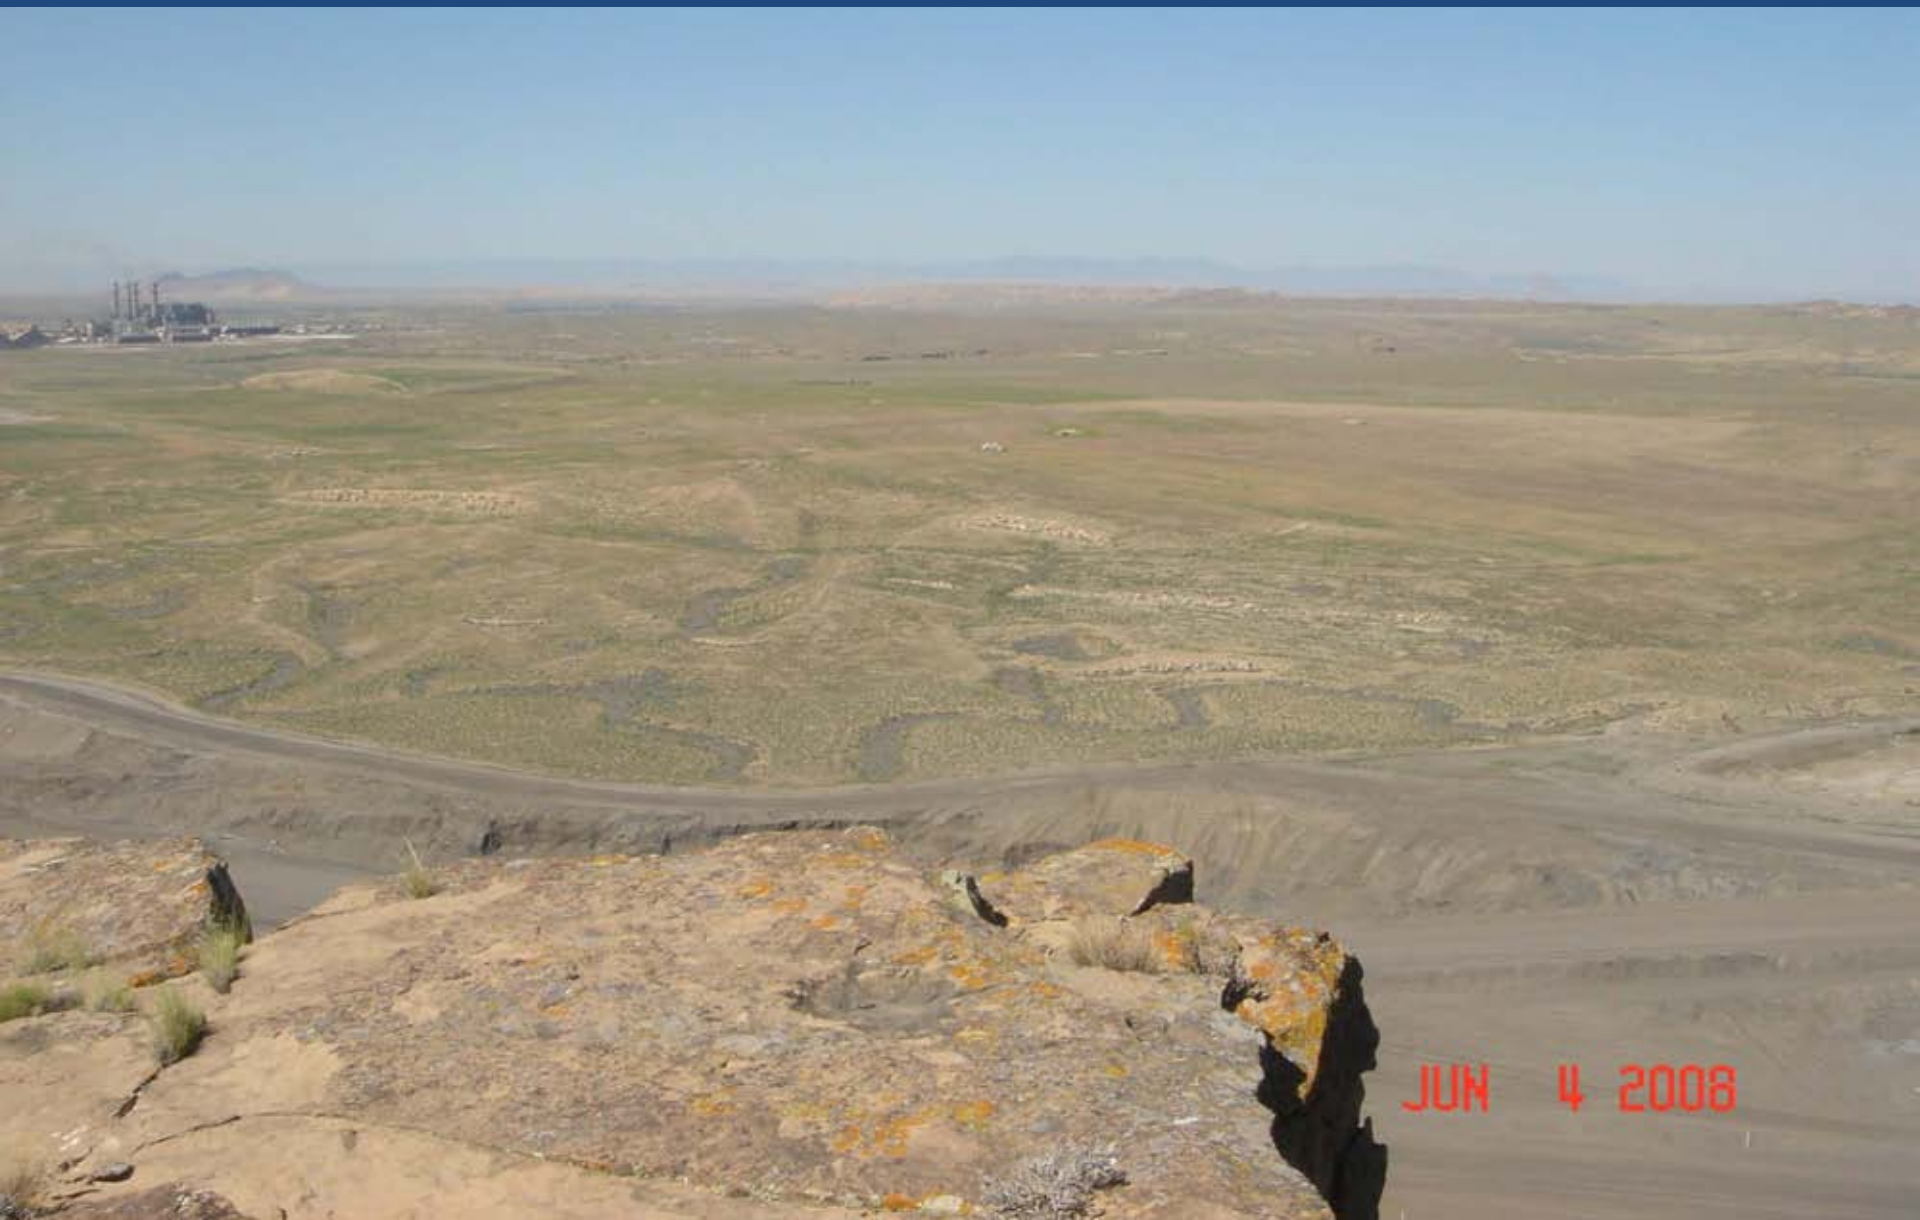
# Reclaimed drainage channels and tie-in with older reclamation at SJM

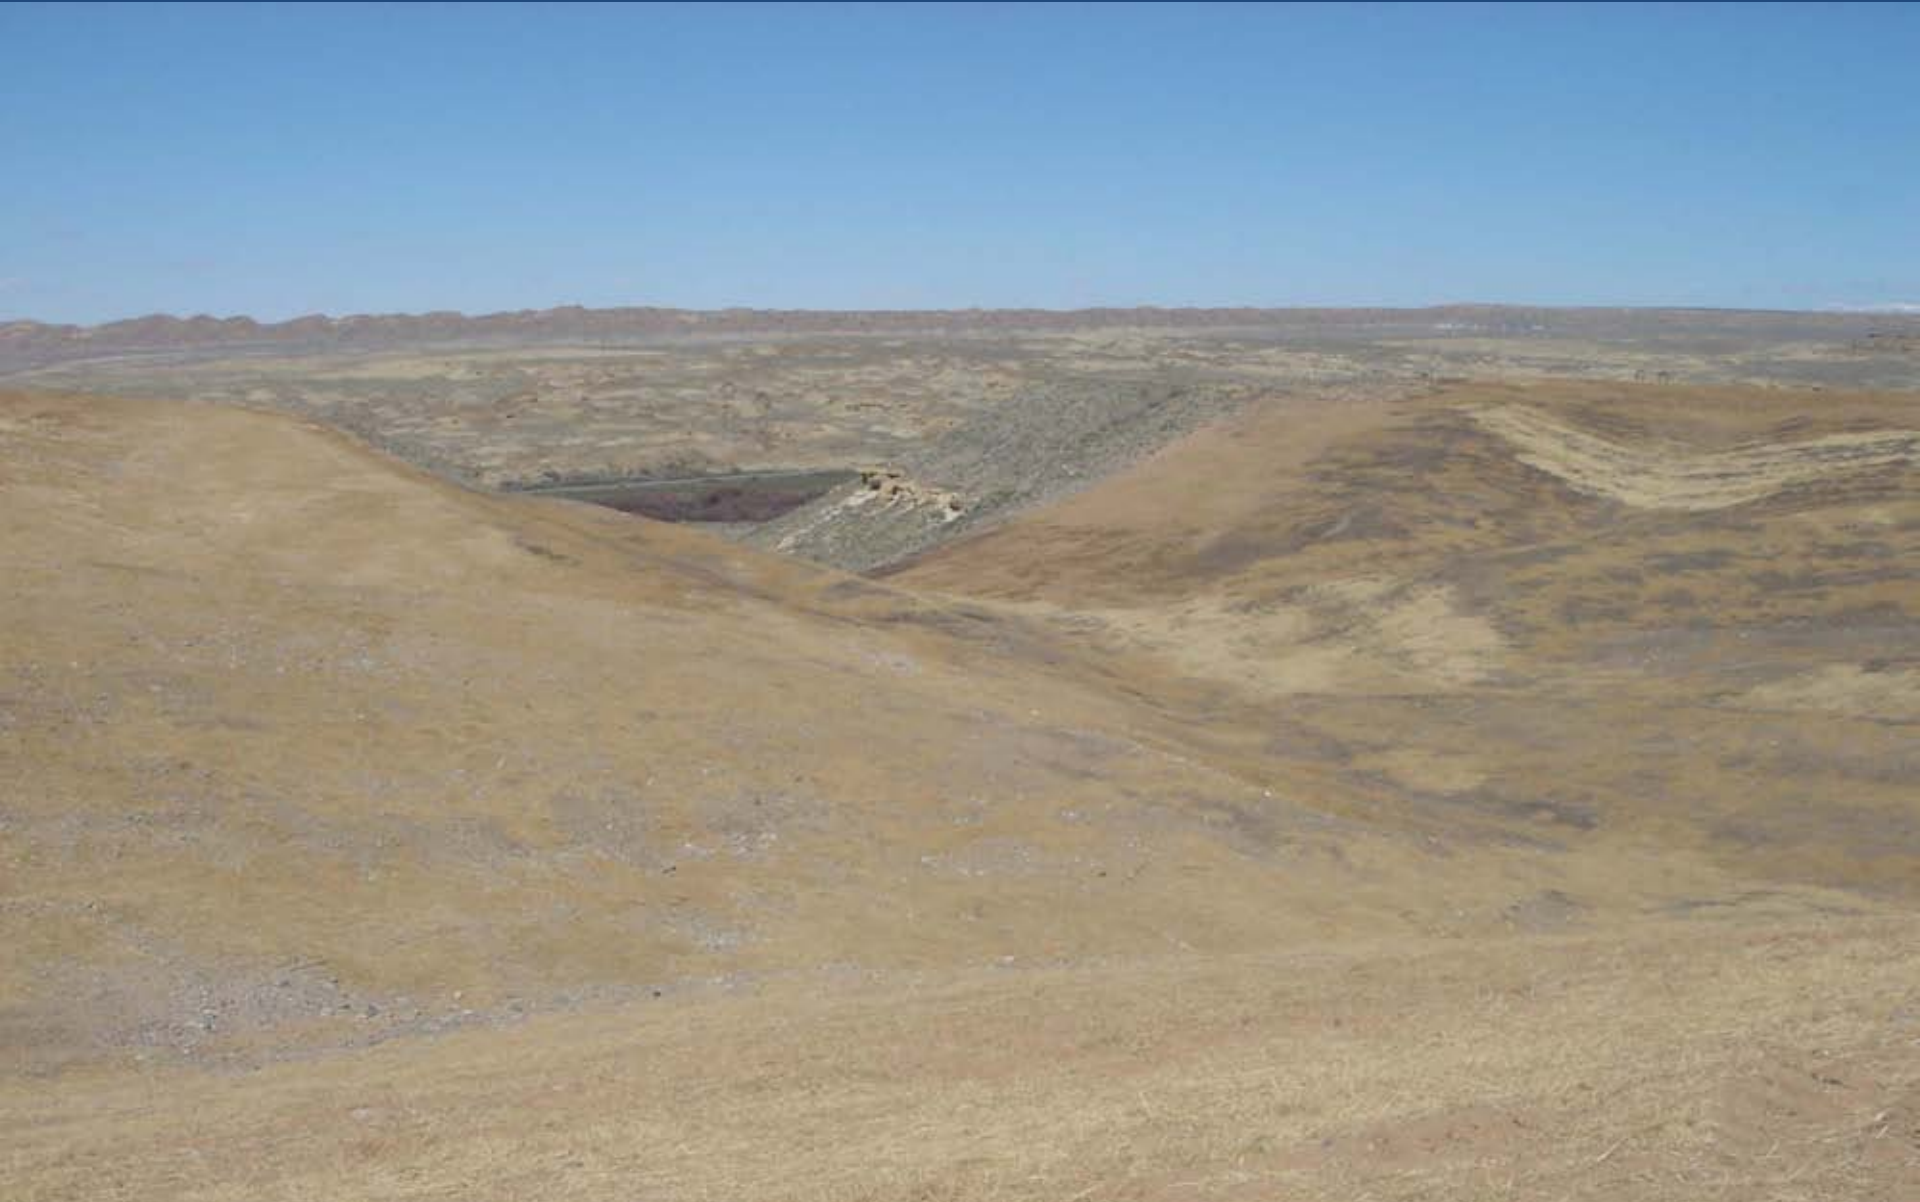
# Tie-in to a native arroyo

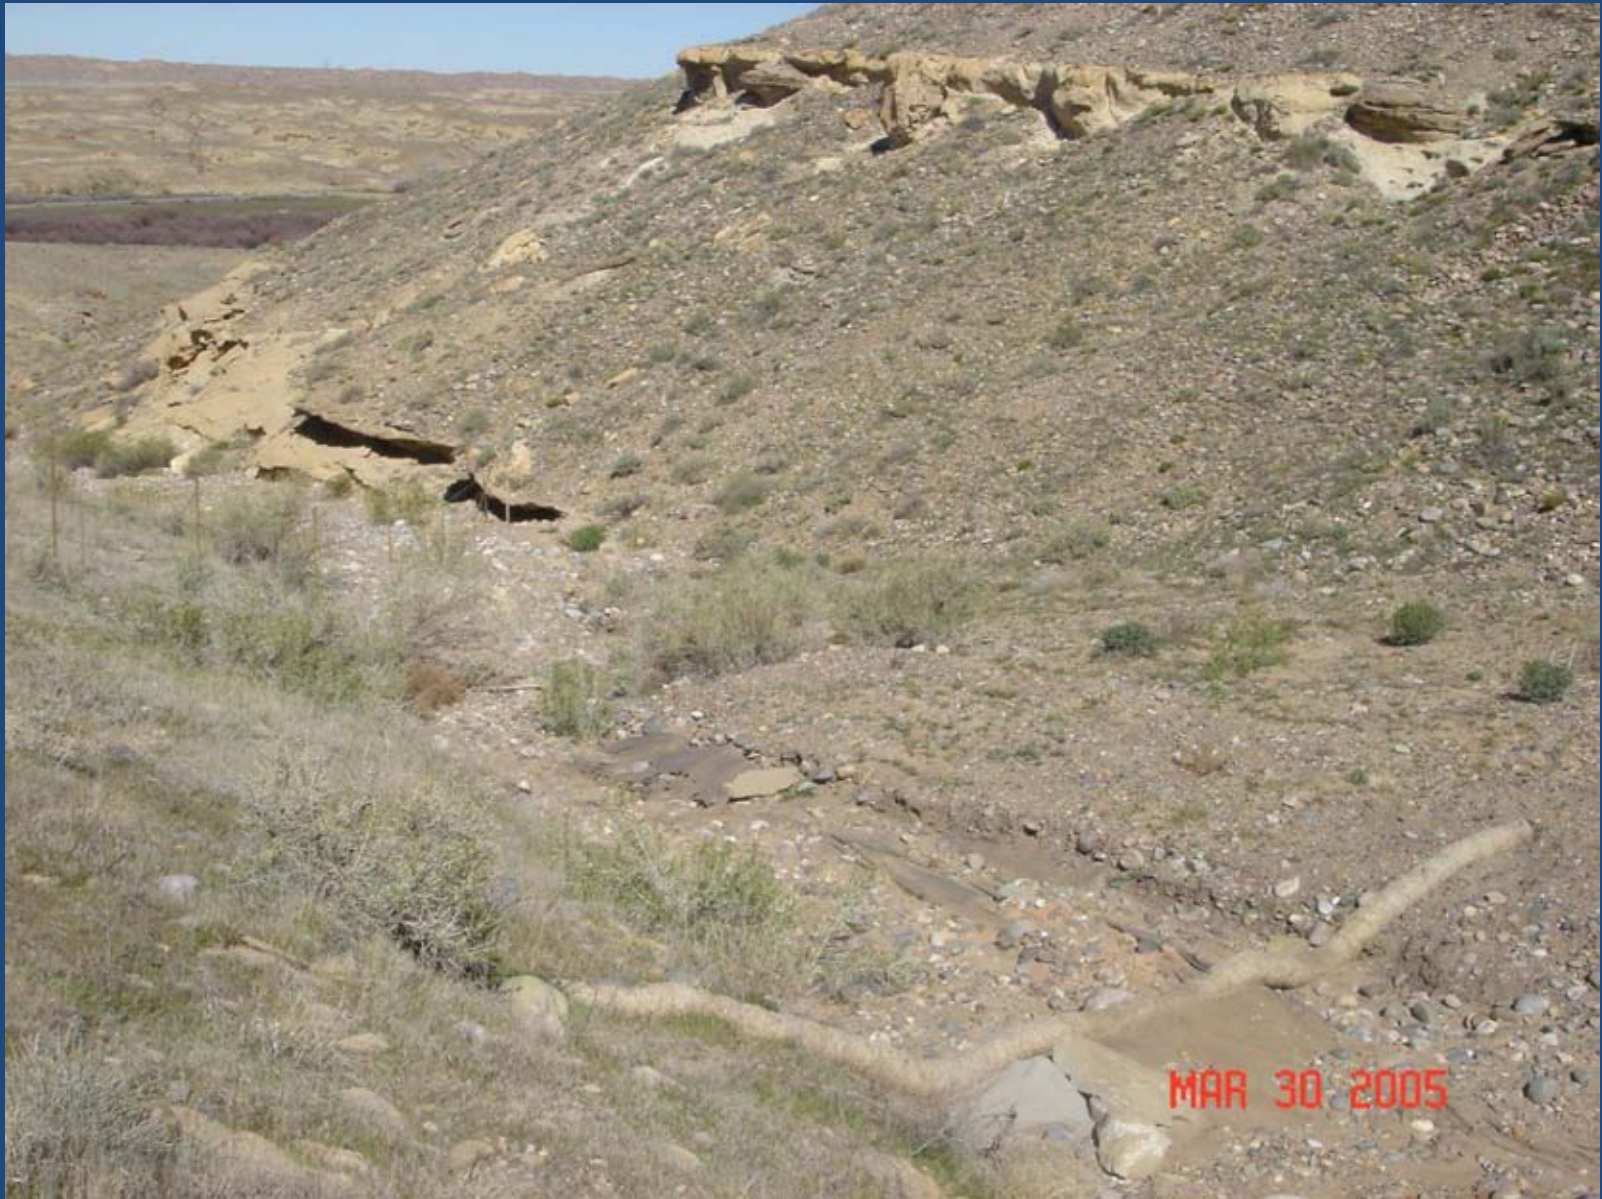
# Close up of transition from reclaim to native

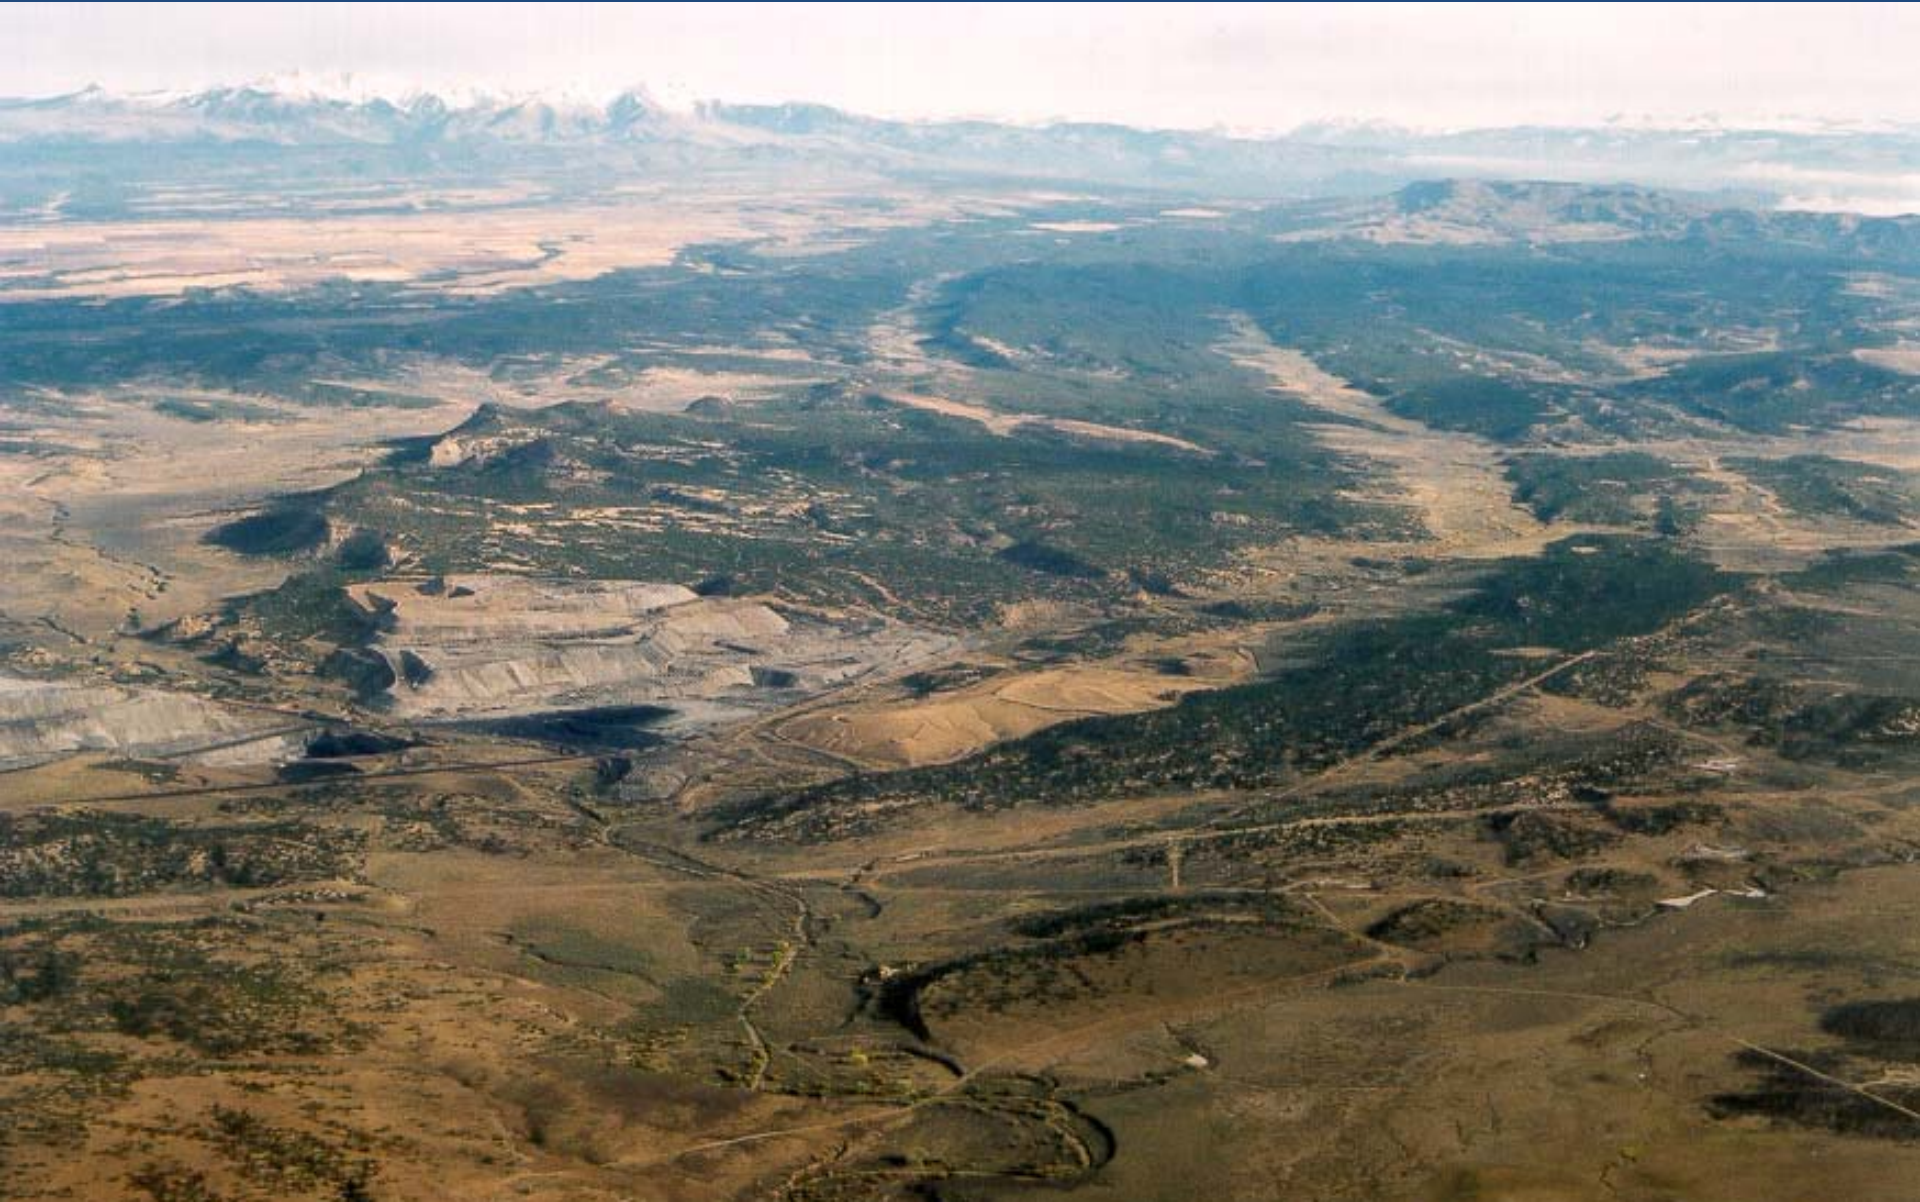
# LPM pre-disturbance type topography with cuestas

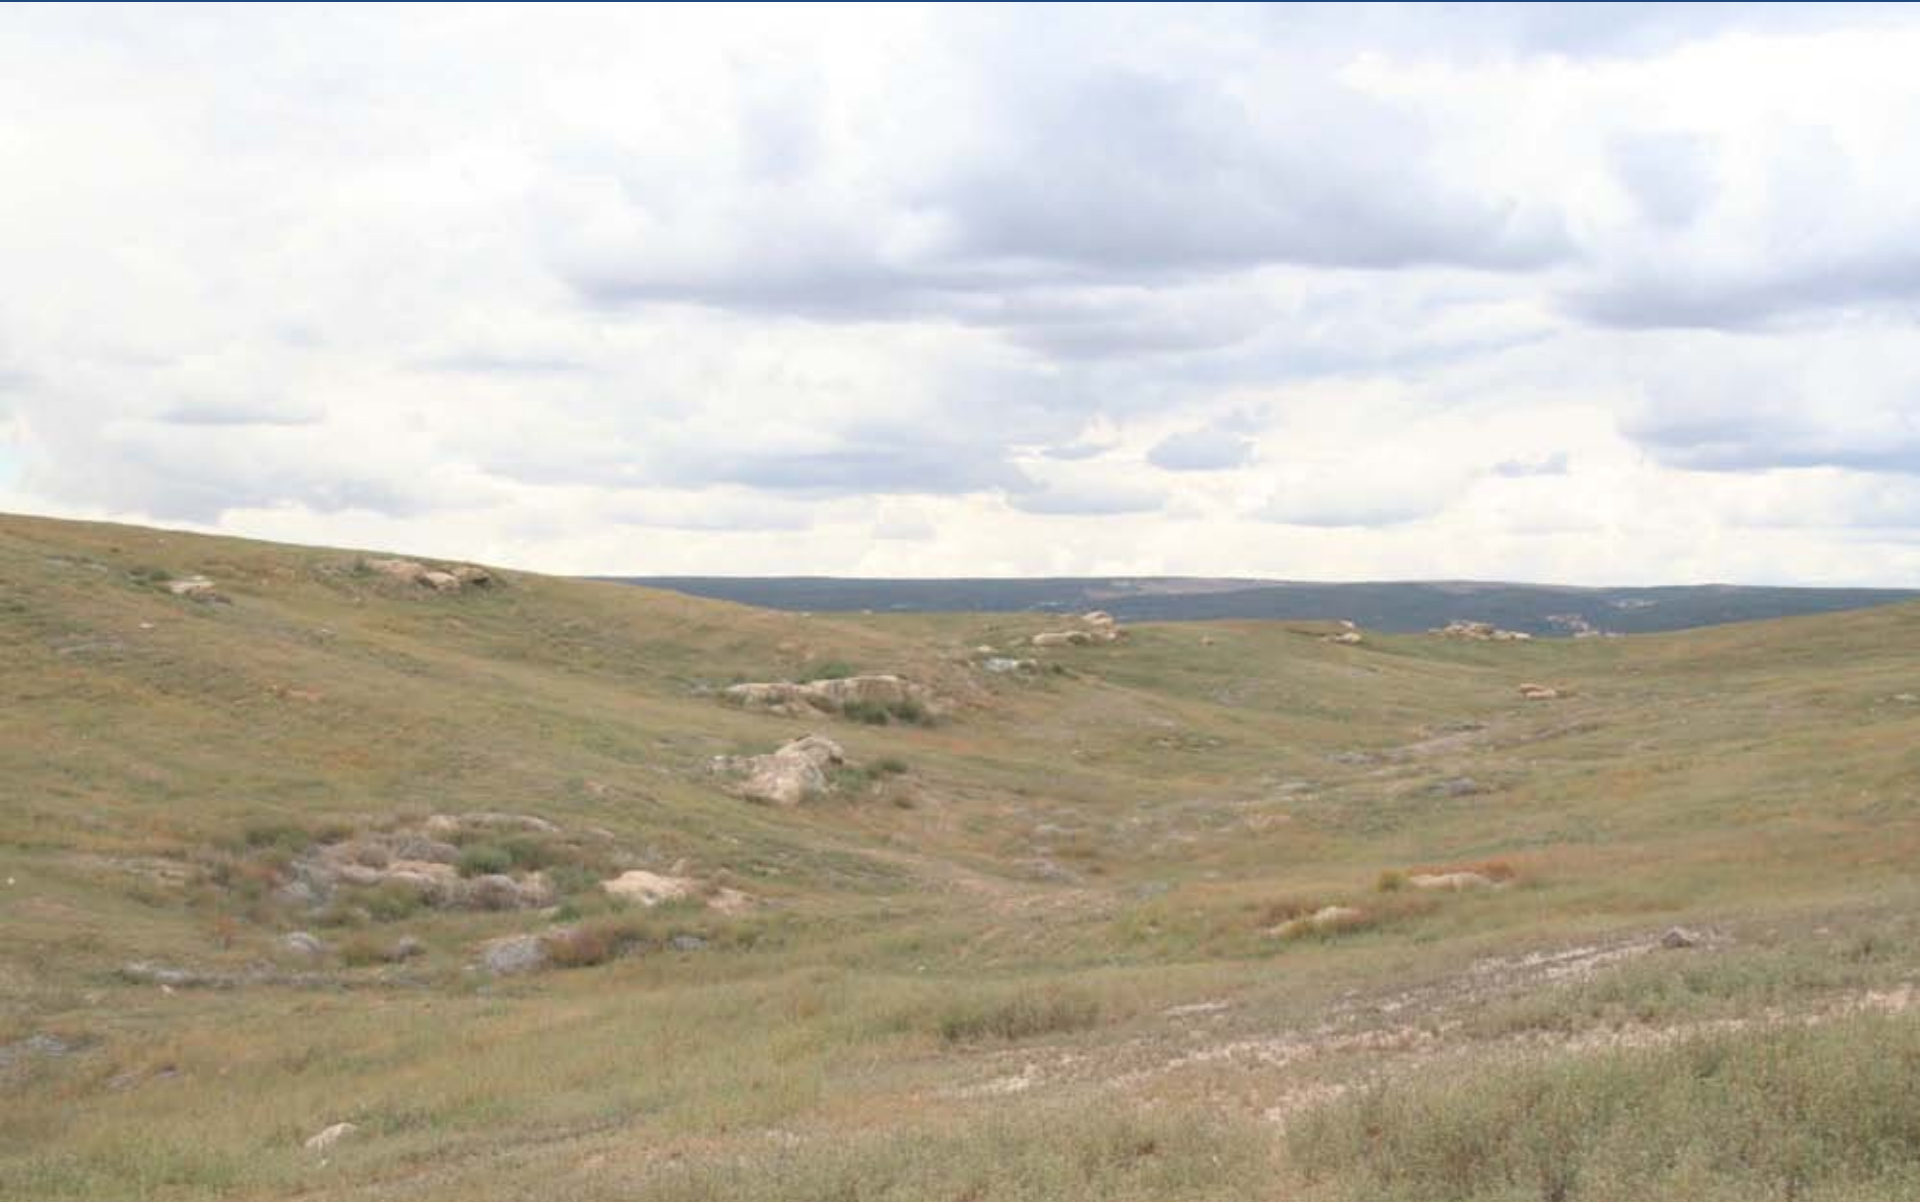
# Artificial outcrops

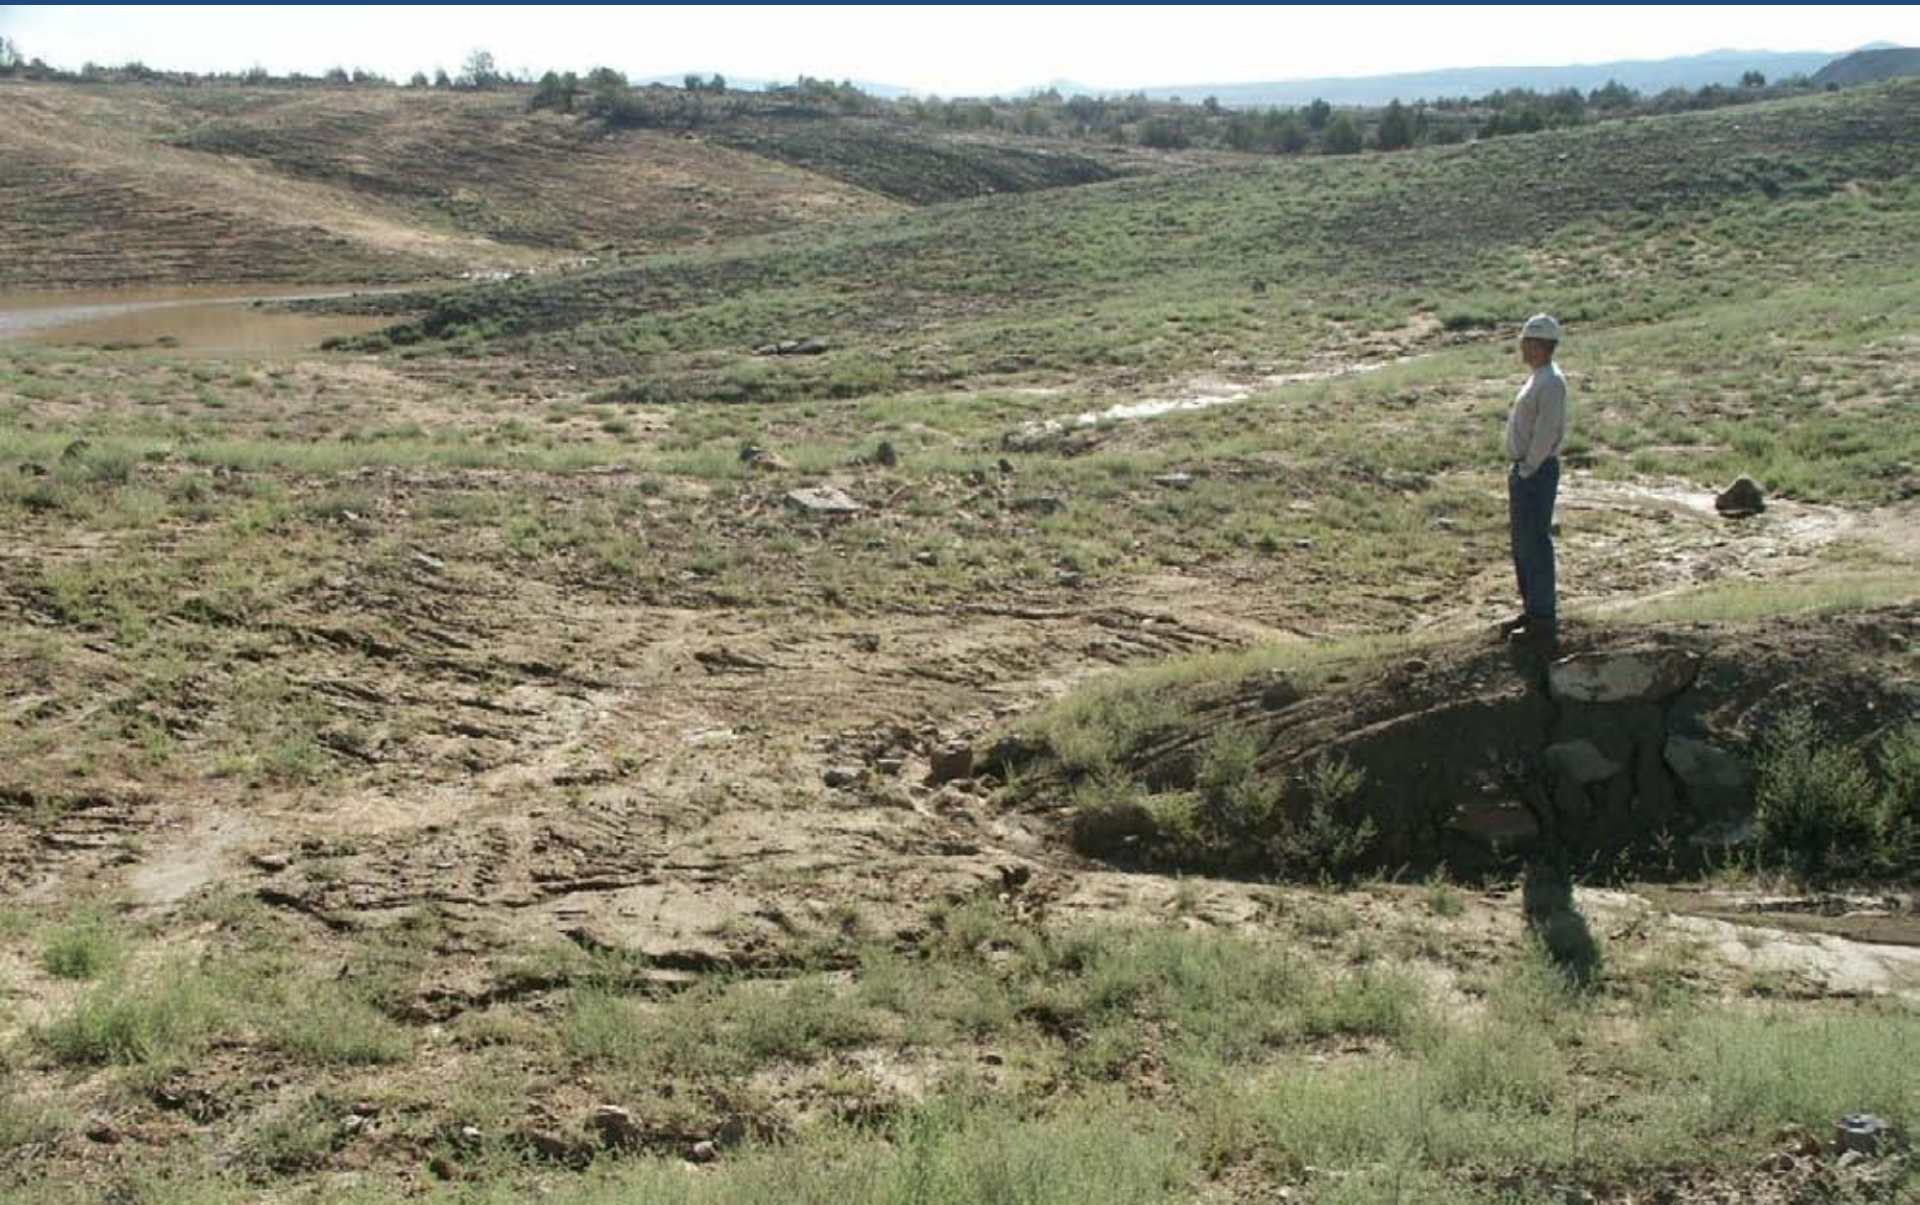
# MMD inspection after a 200-yr/2-hr storm

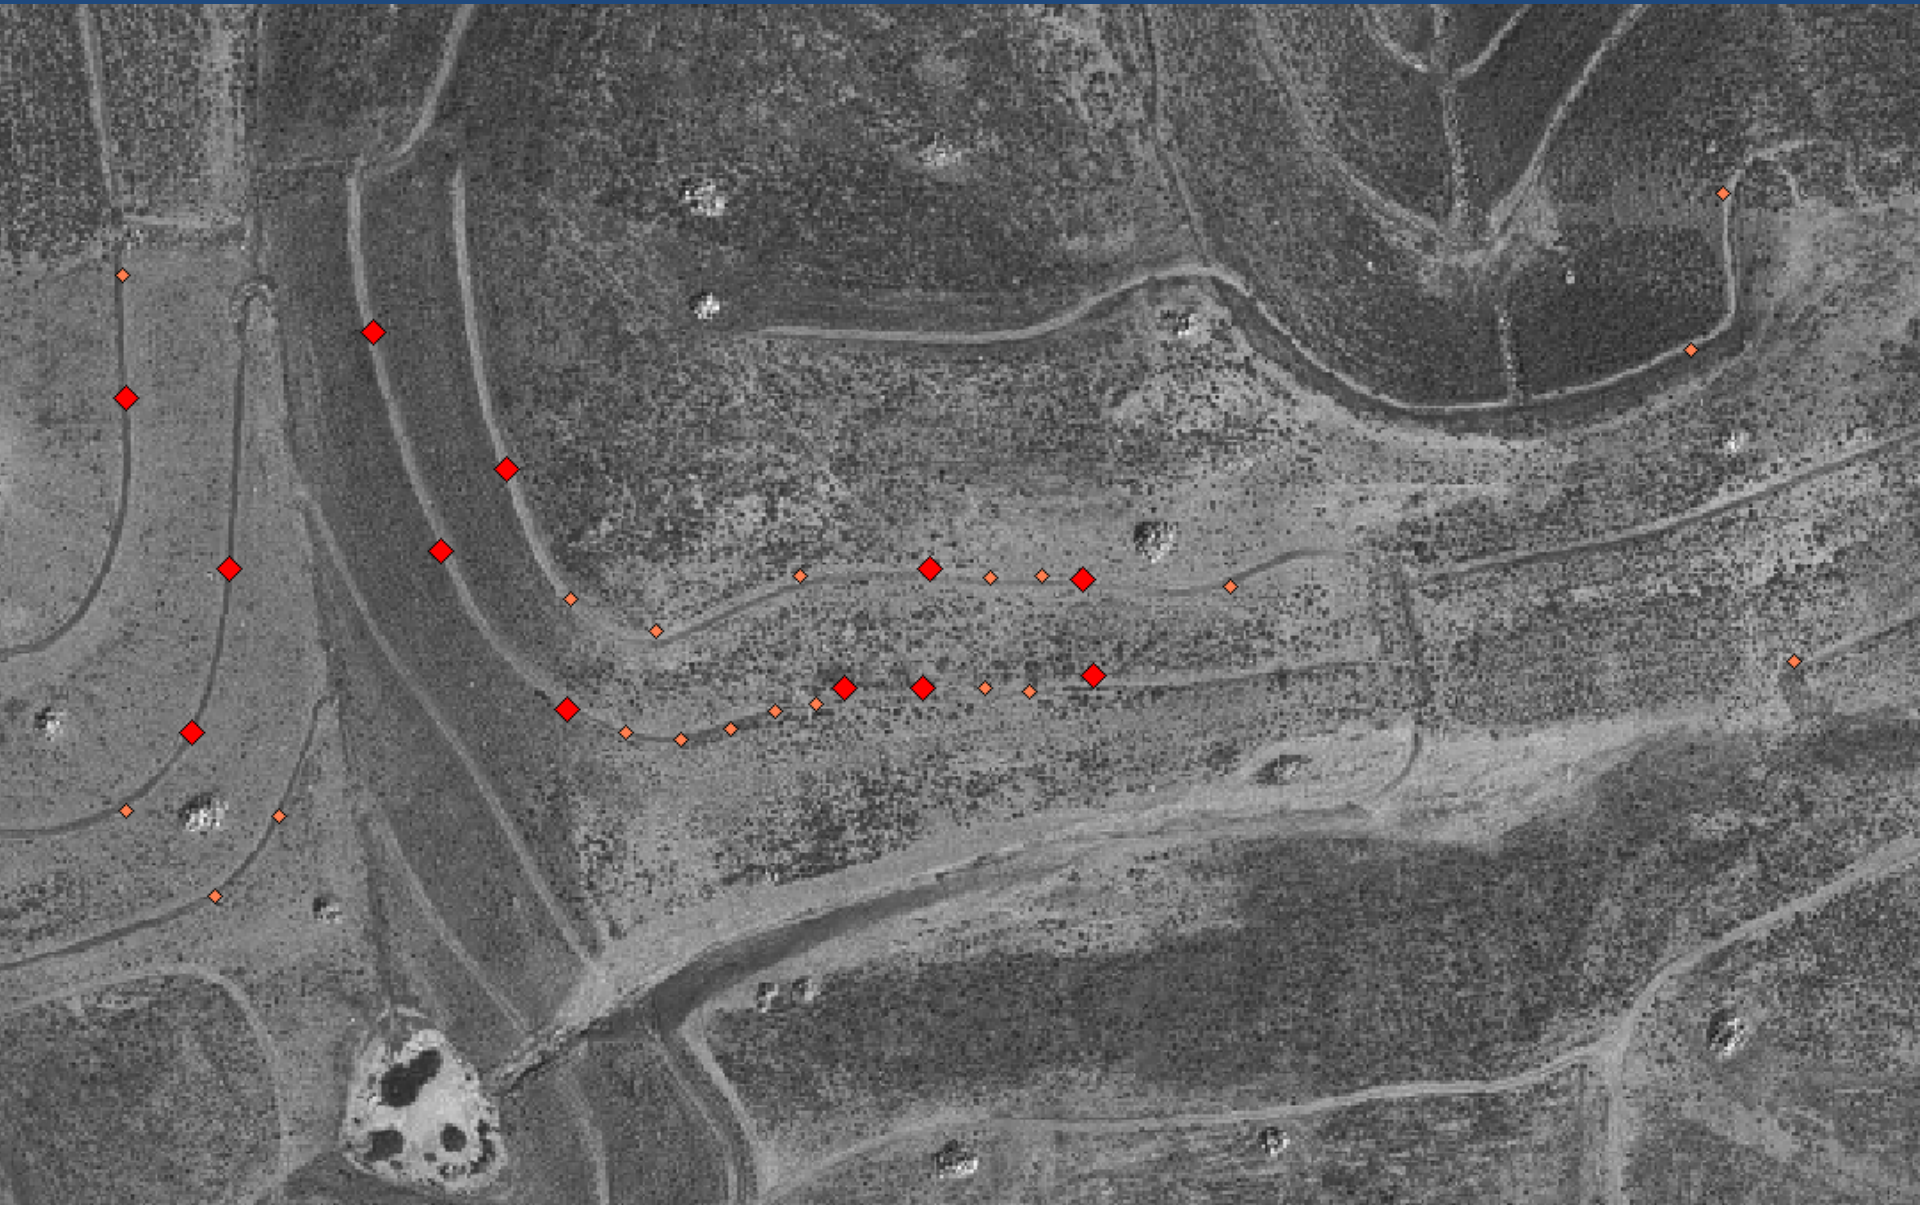
# McKinley Mine

## Subsidence piping features on terraced reclamation
