# **Geomorphic Reclamation in New Mexico: A Regulator's Perspective**

**Dave Clark**

**NM Mining and Minerals Division**

**AUG 28 2008**

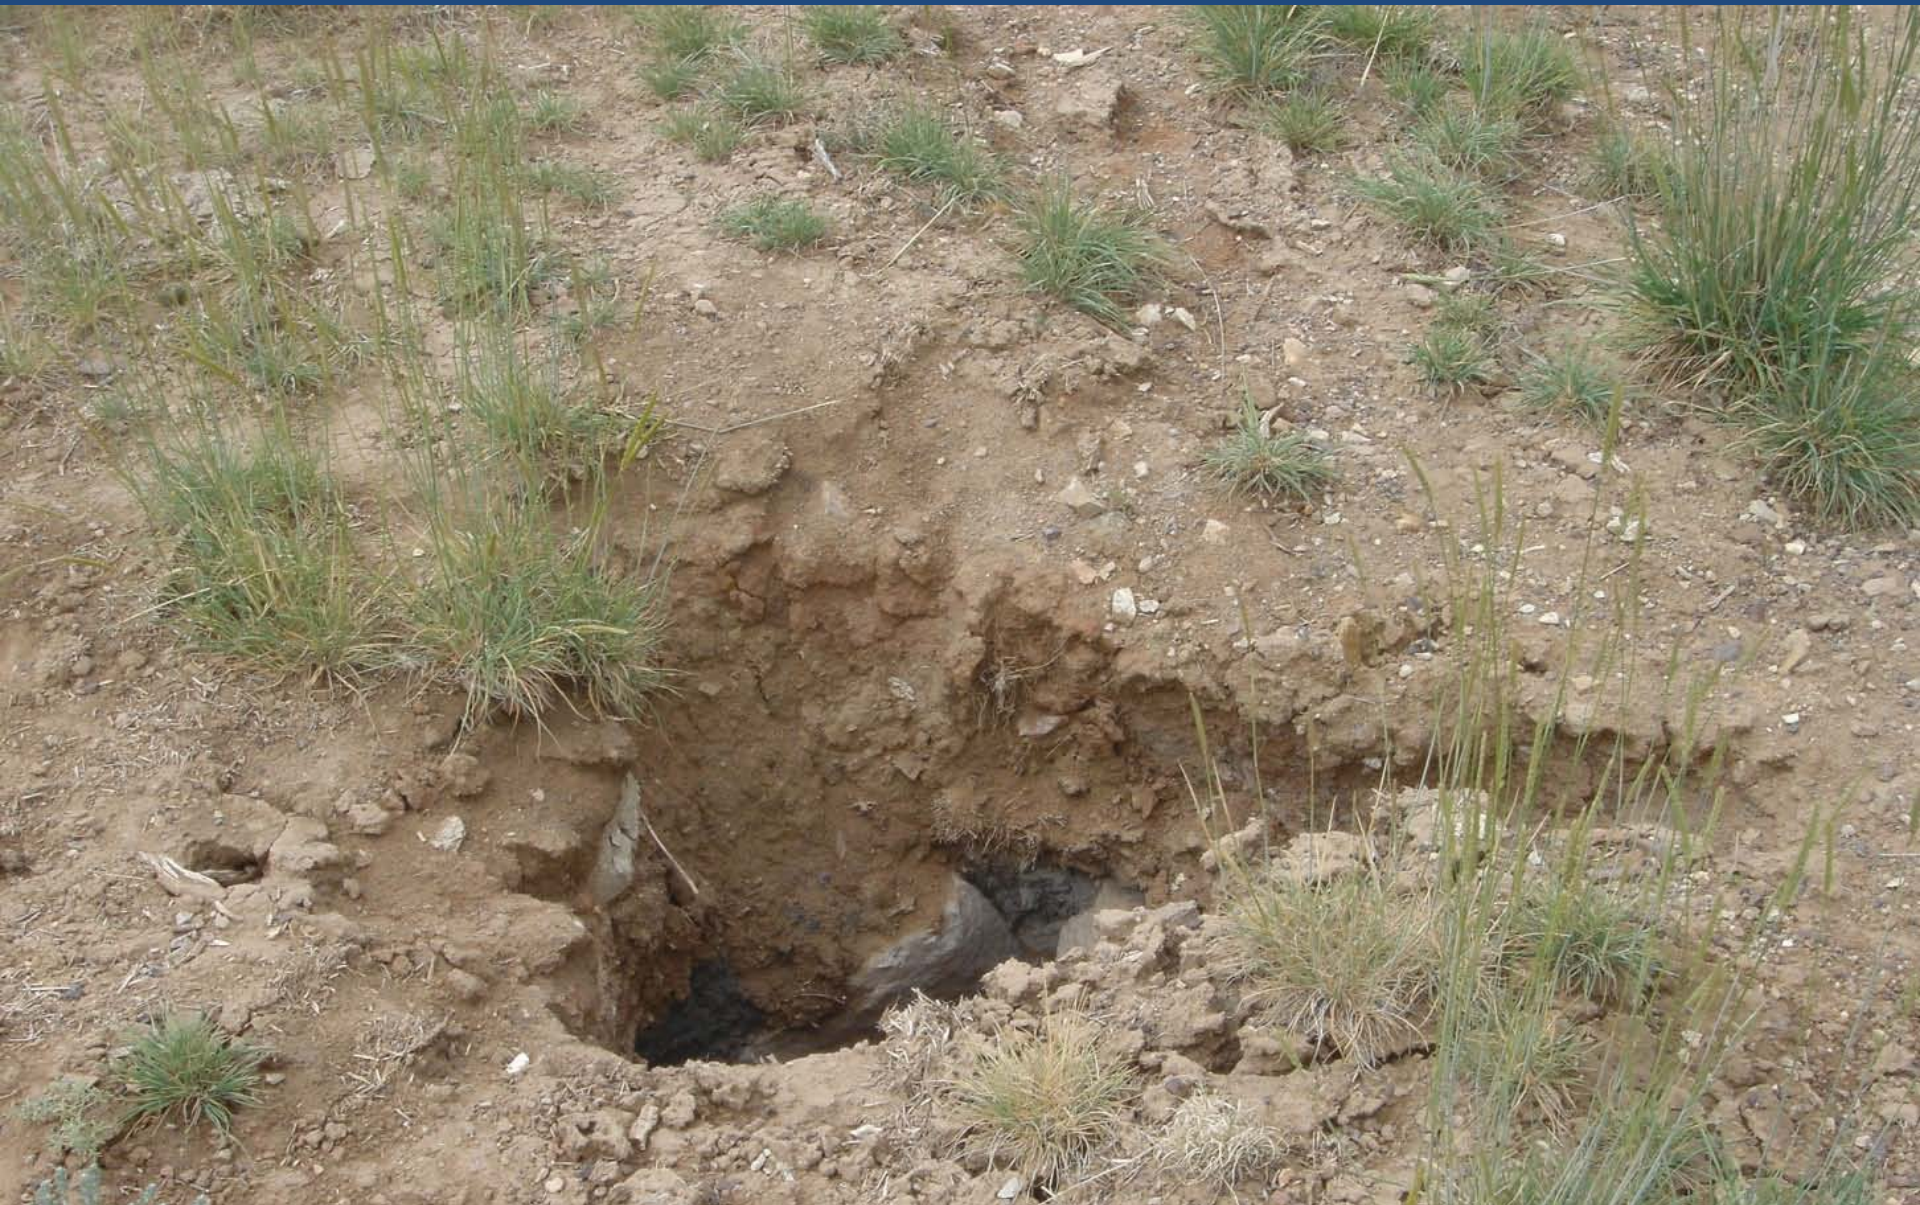
# Piping hole

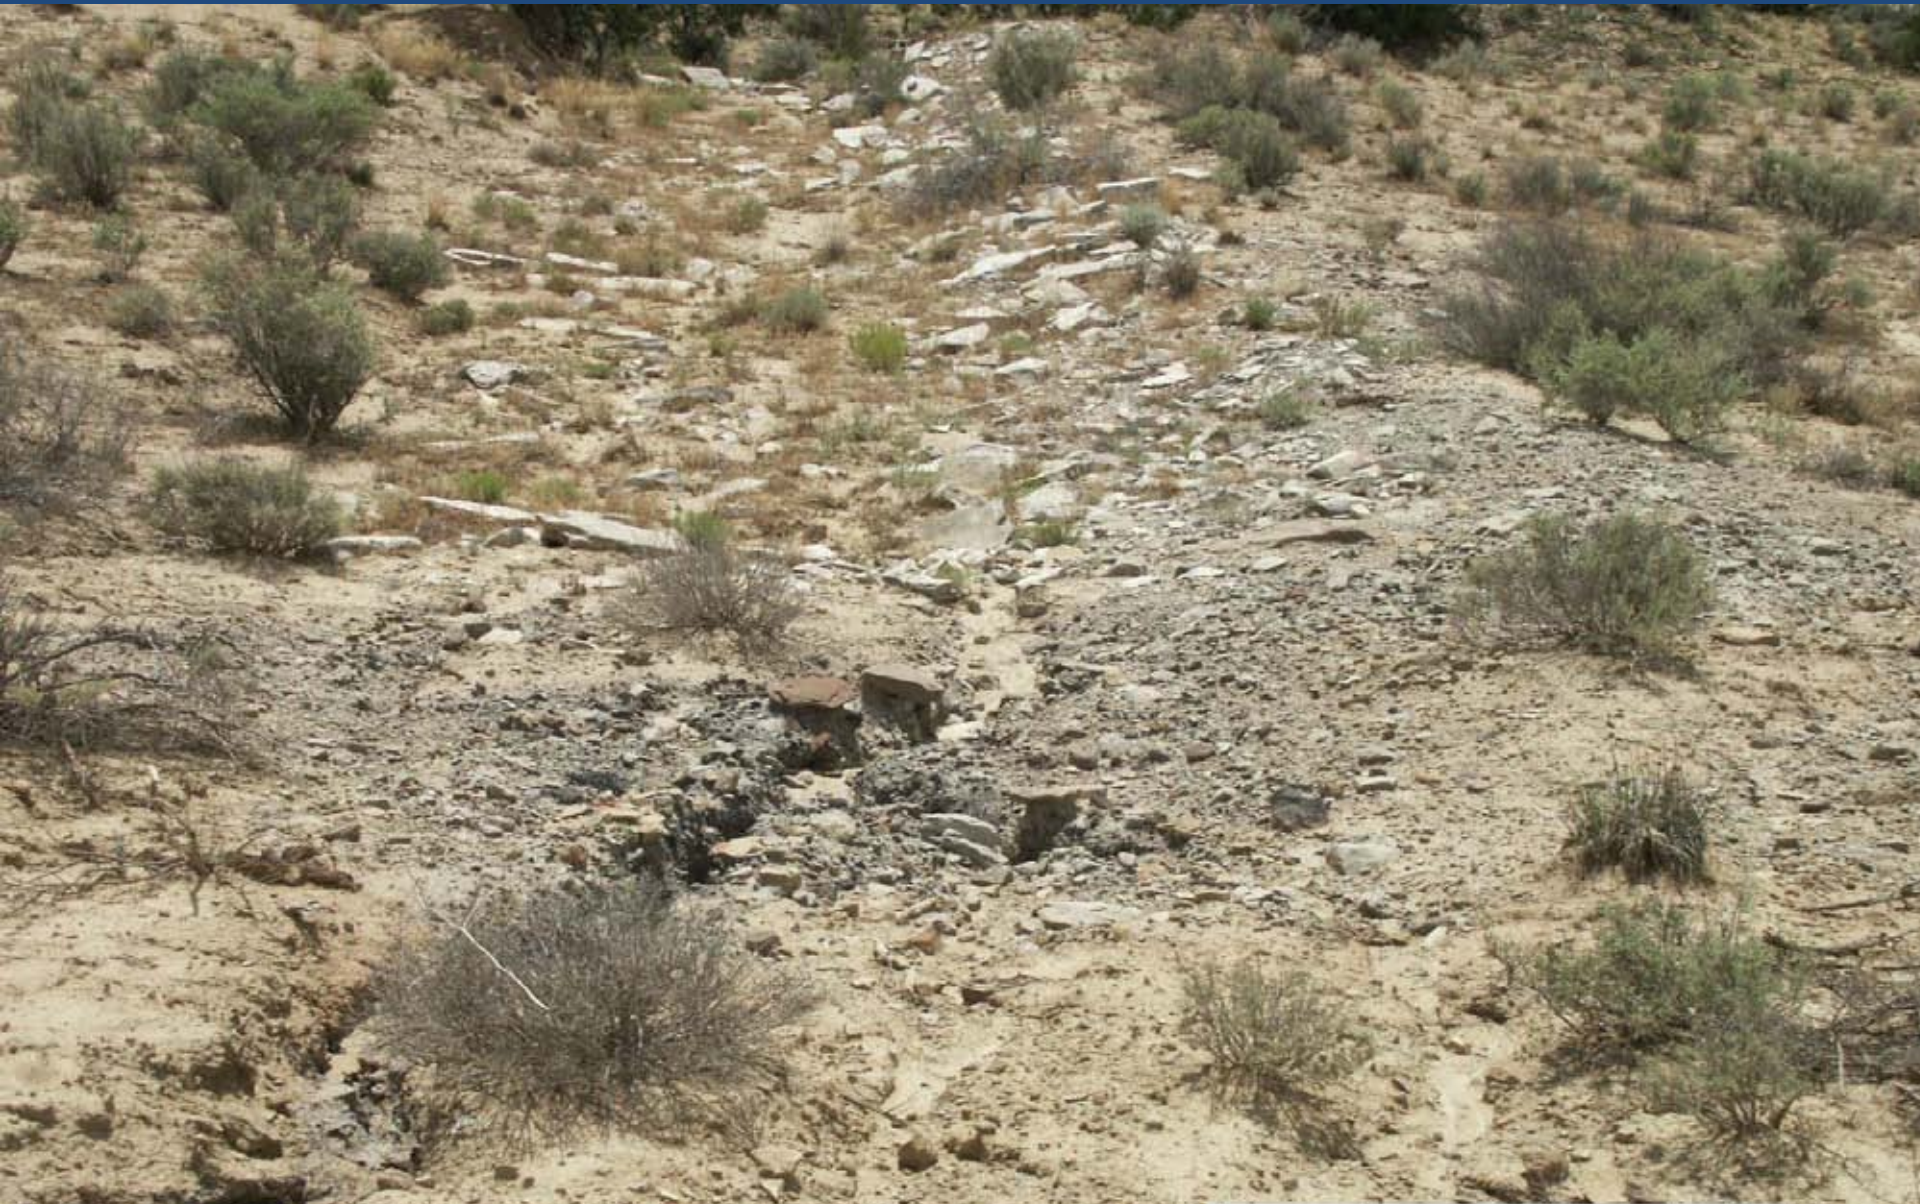
# Differential settling on a terrace

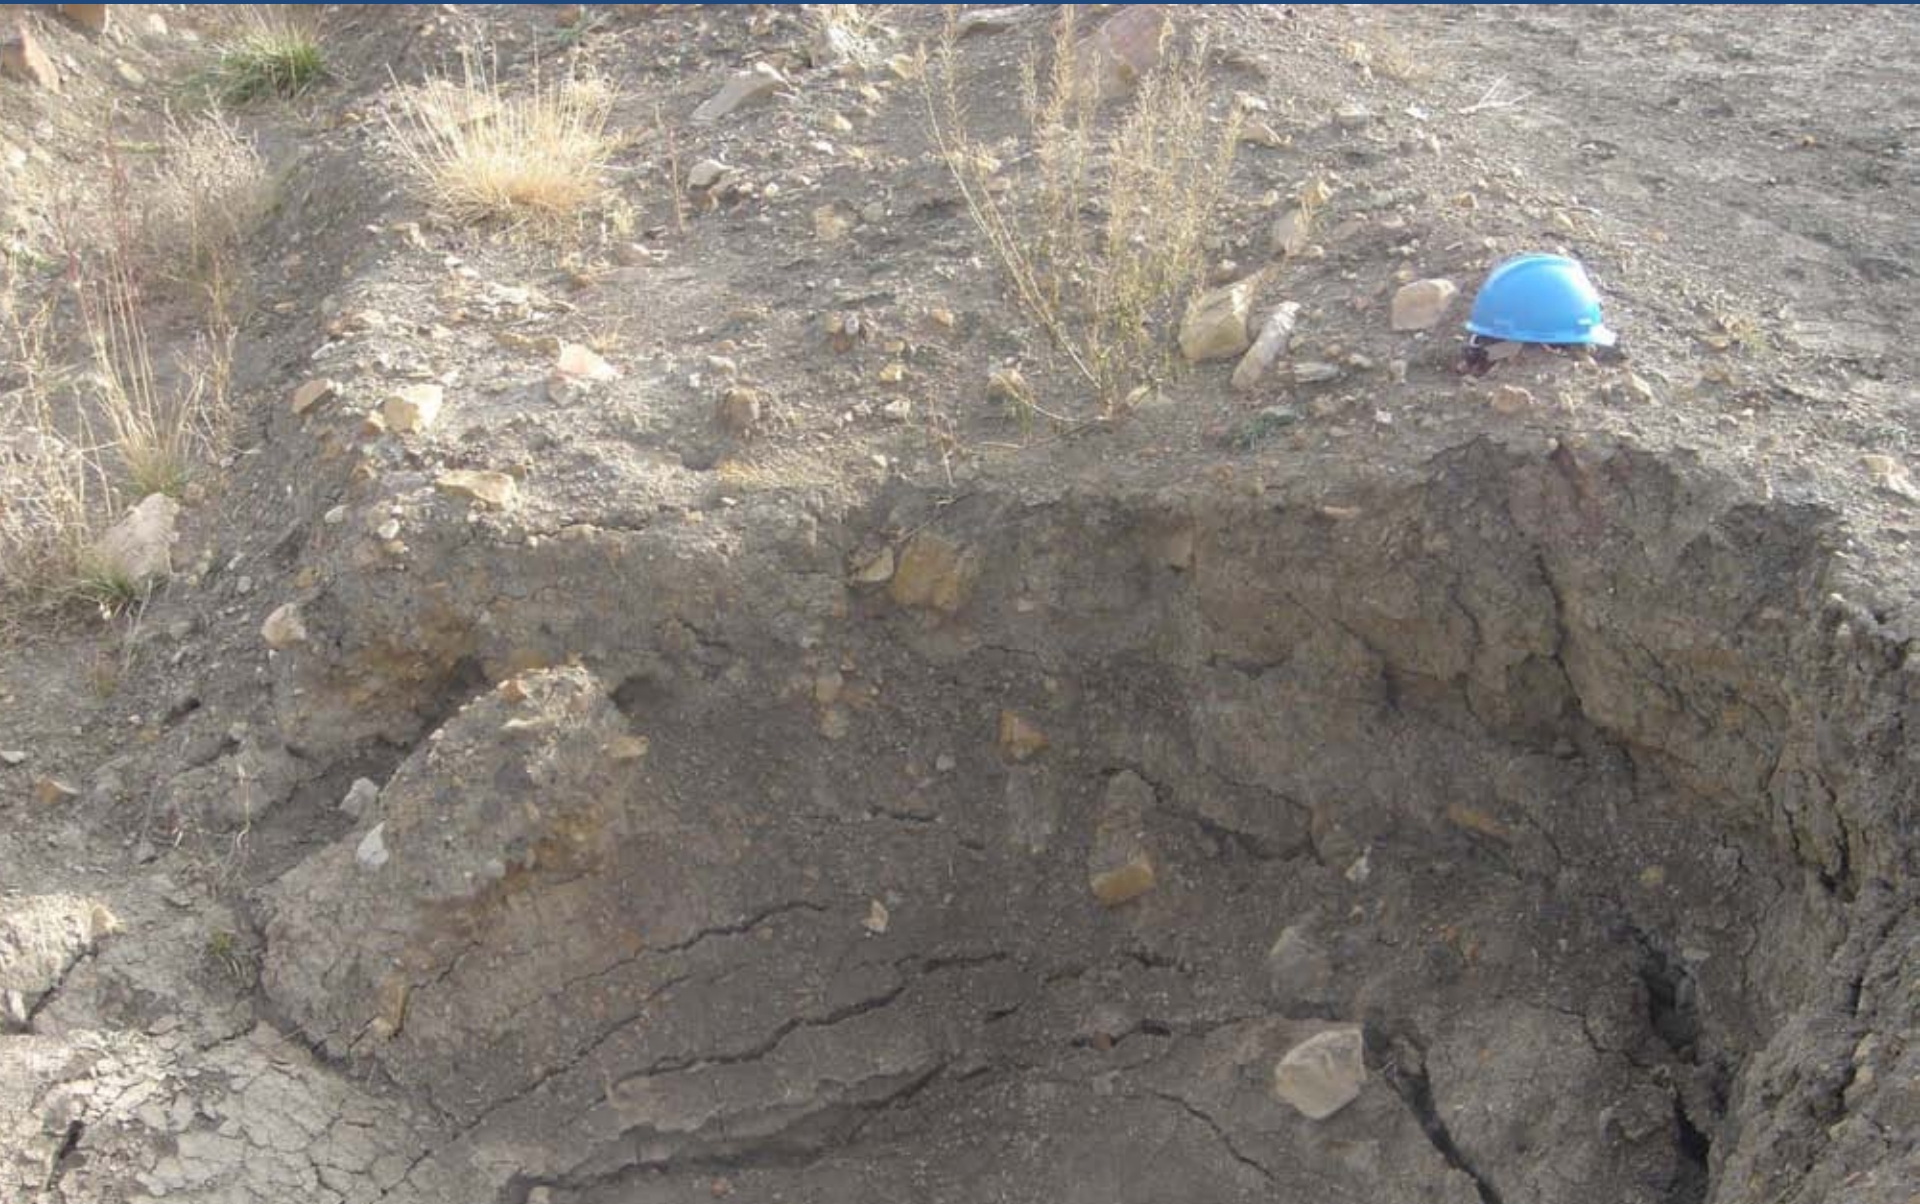
Major feature requiring costly repair and  
creating liability concerns

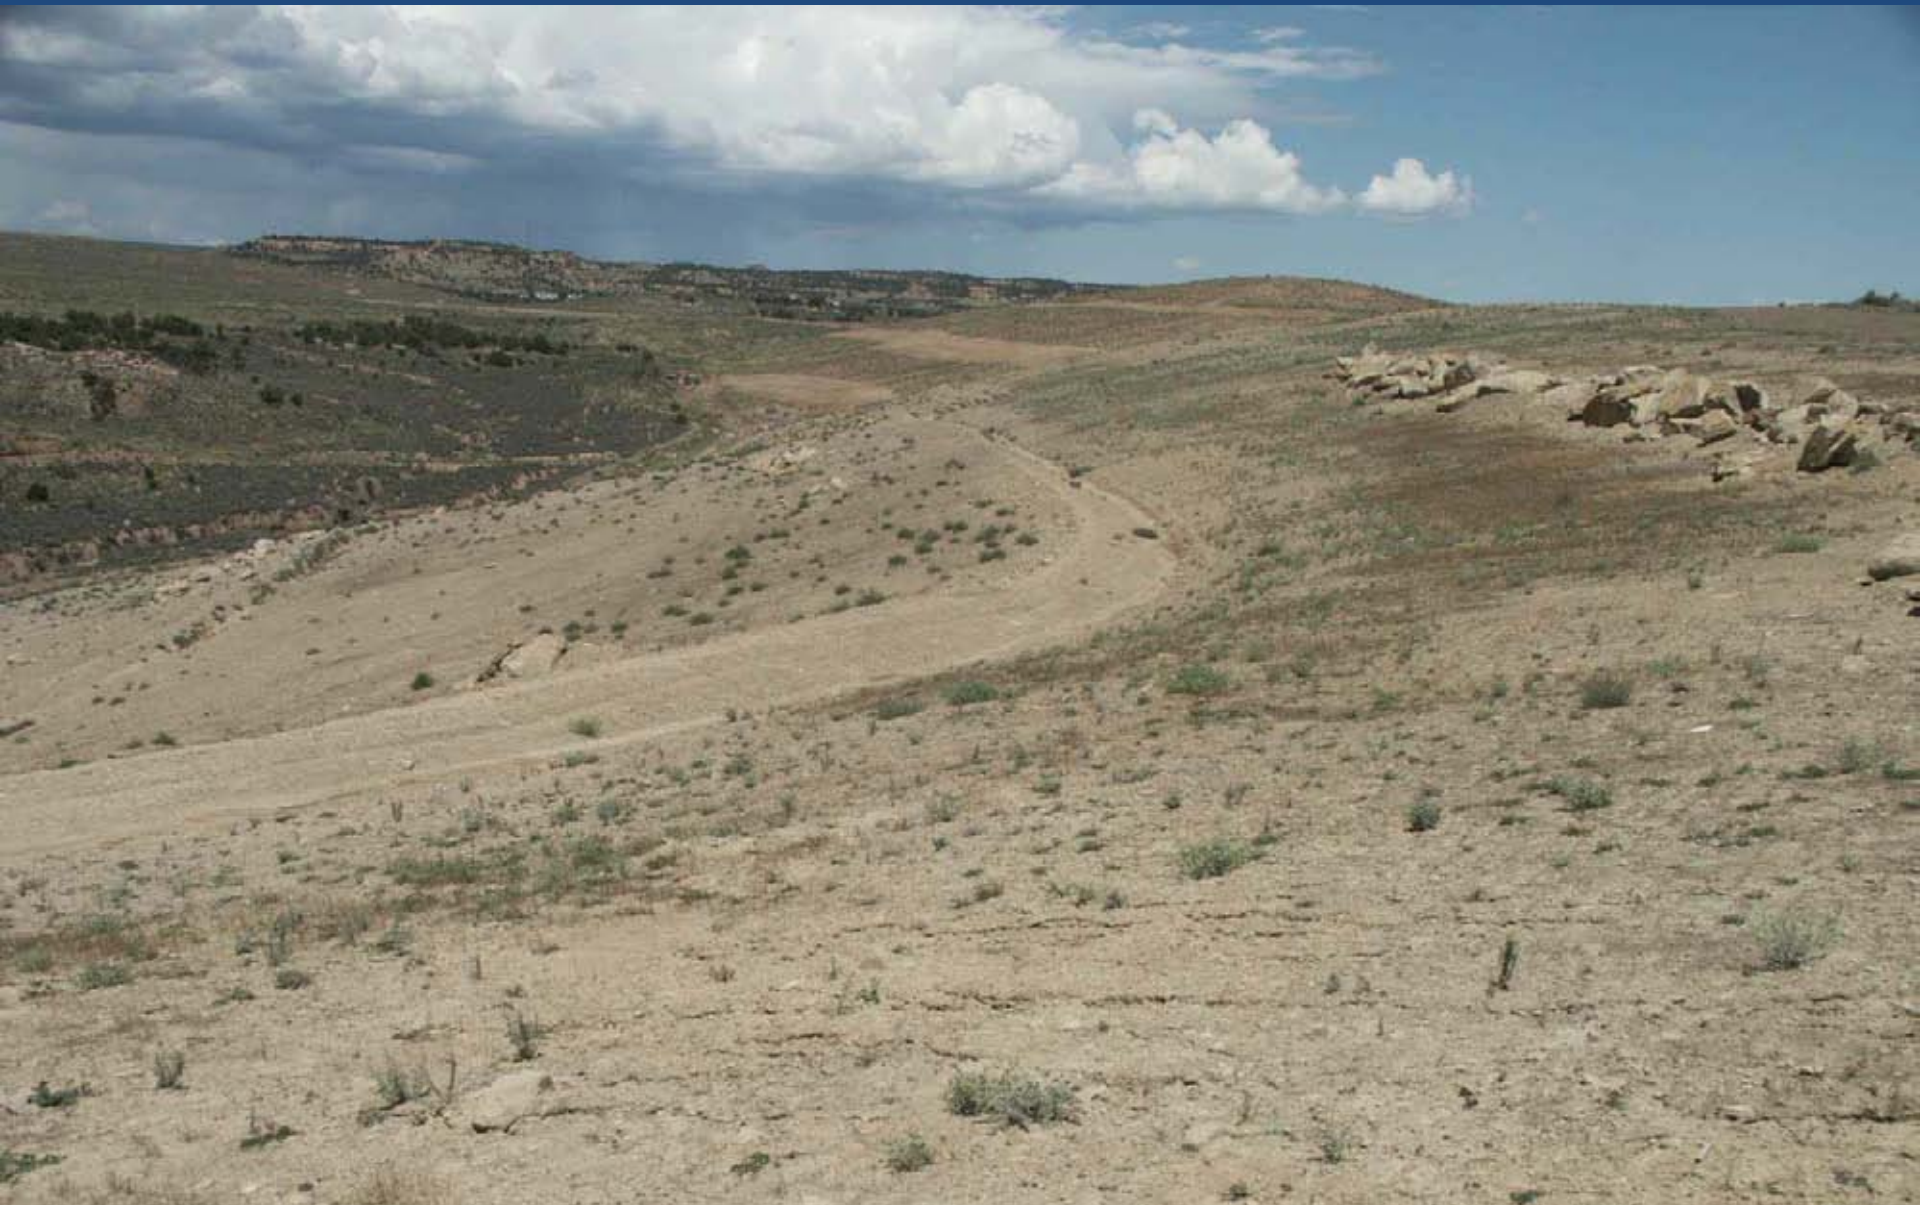
# Area 9 terrace, over-steepened cut slope

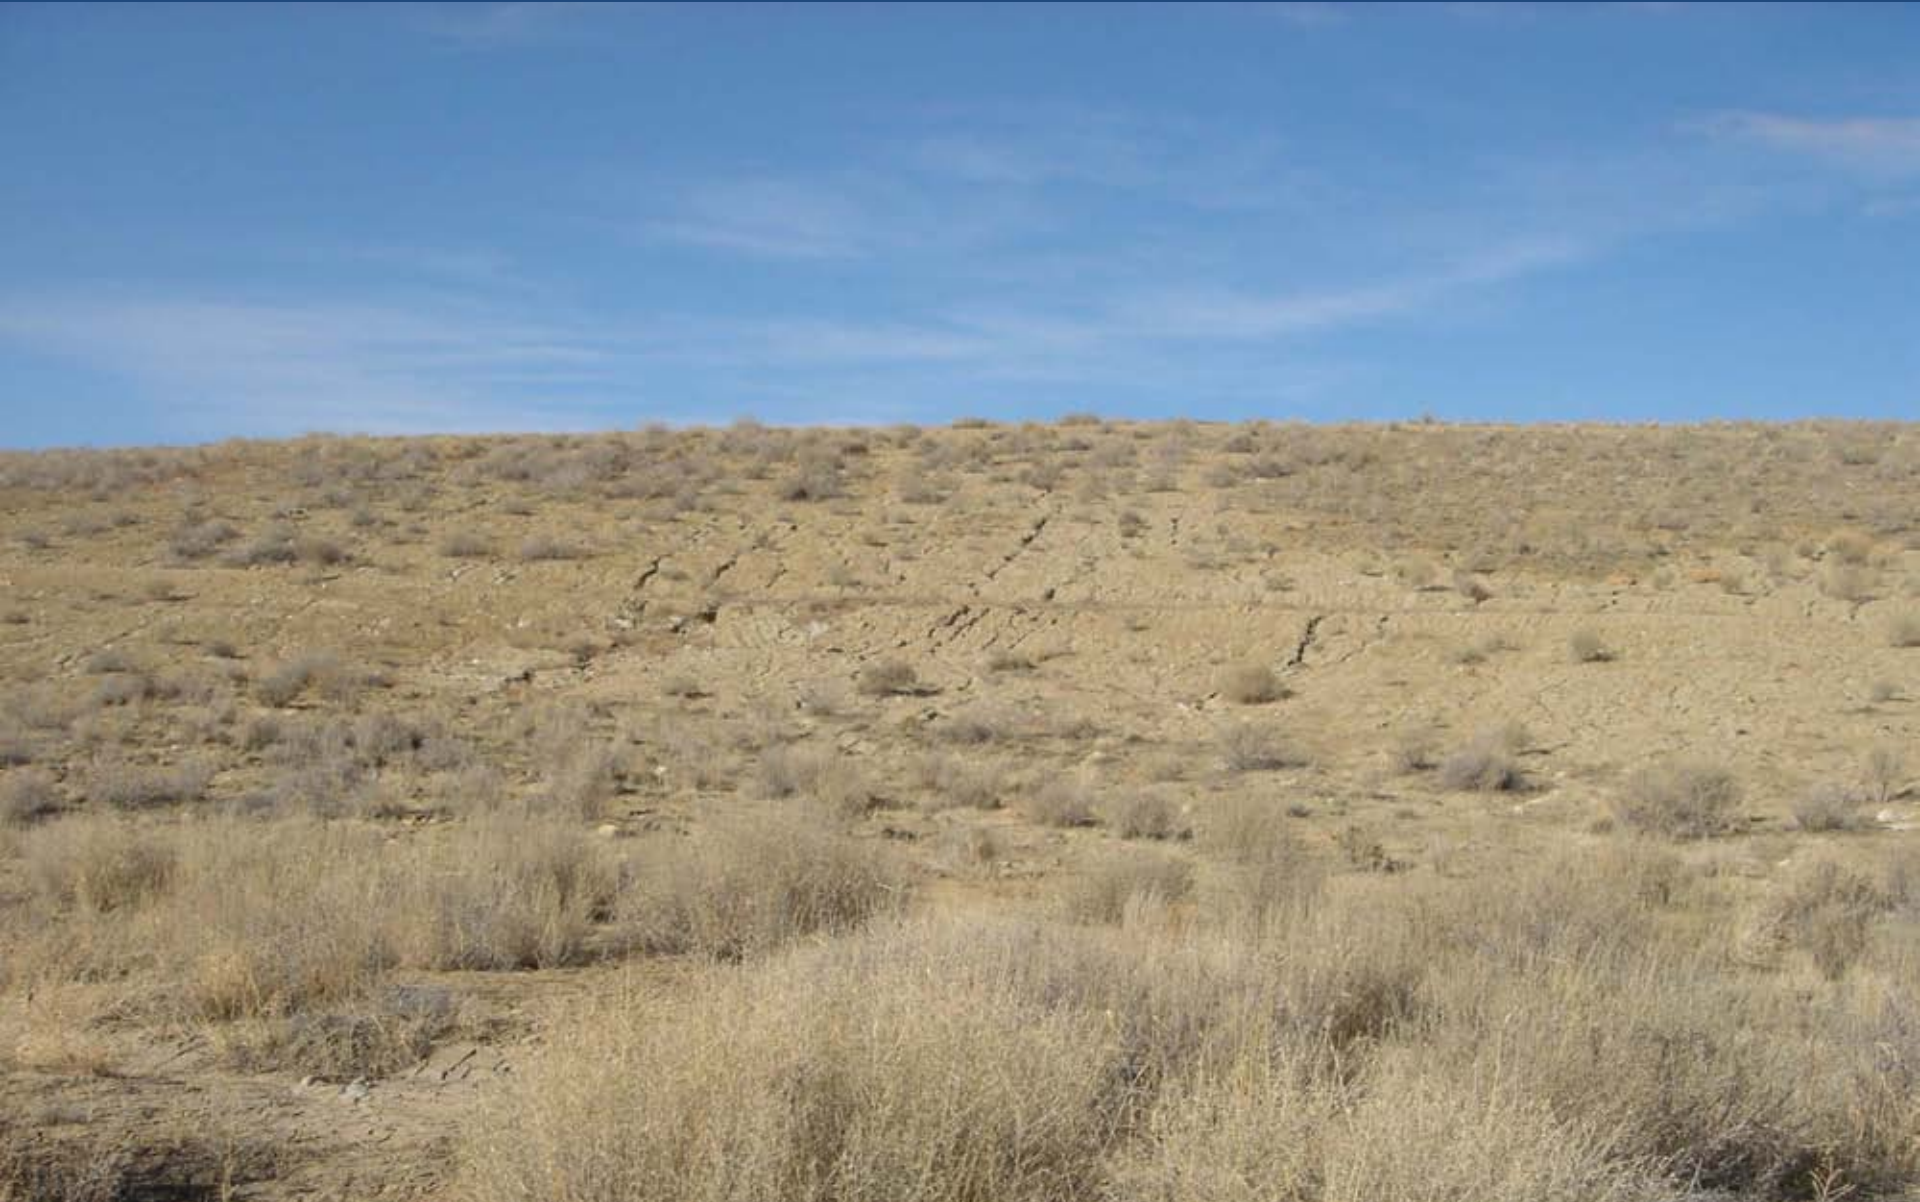
Erosion, flow blockage, differential settling, breach

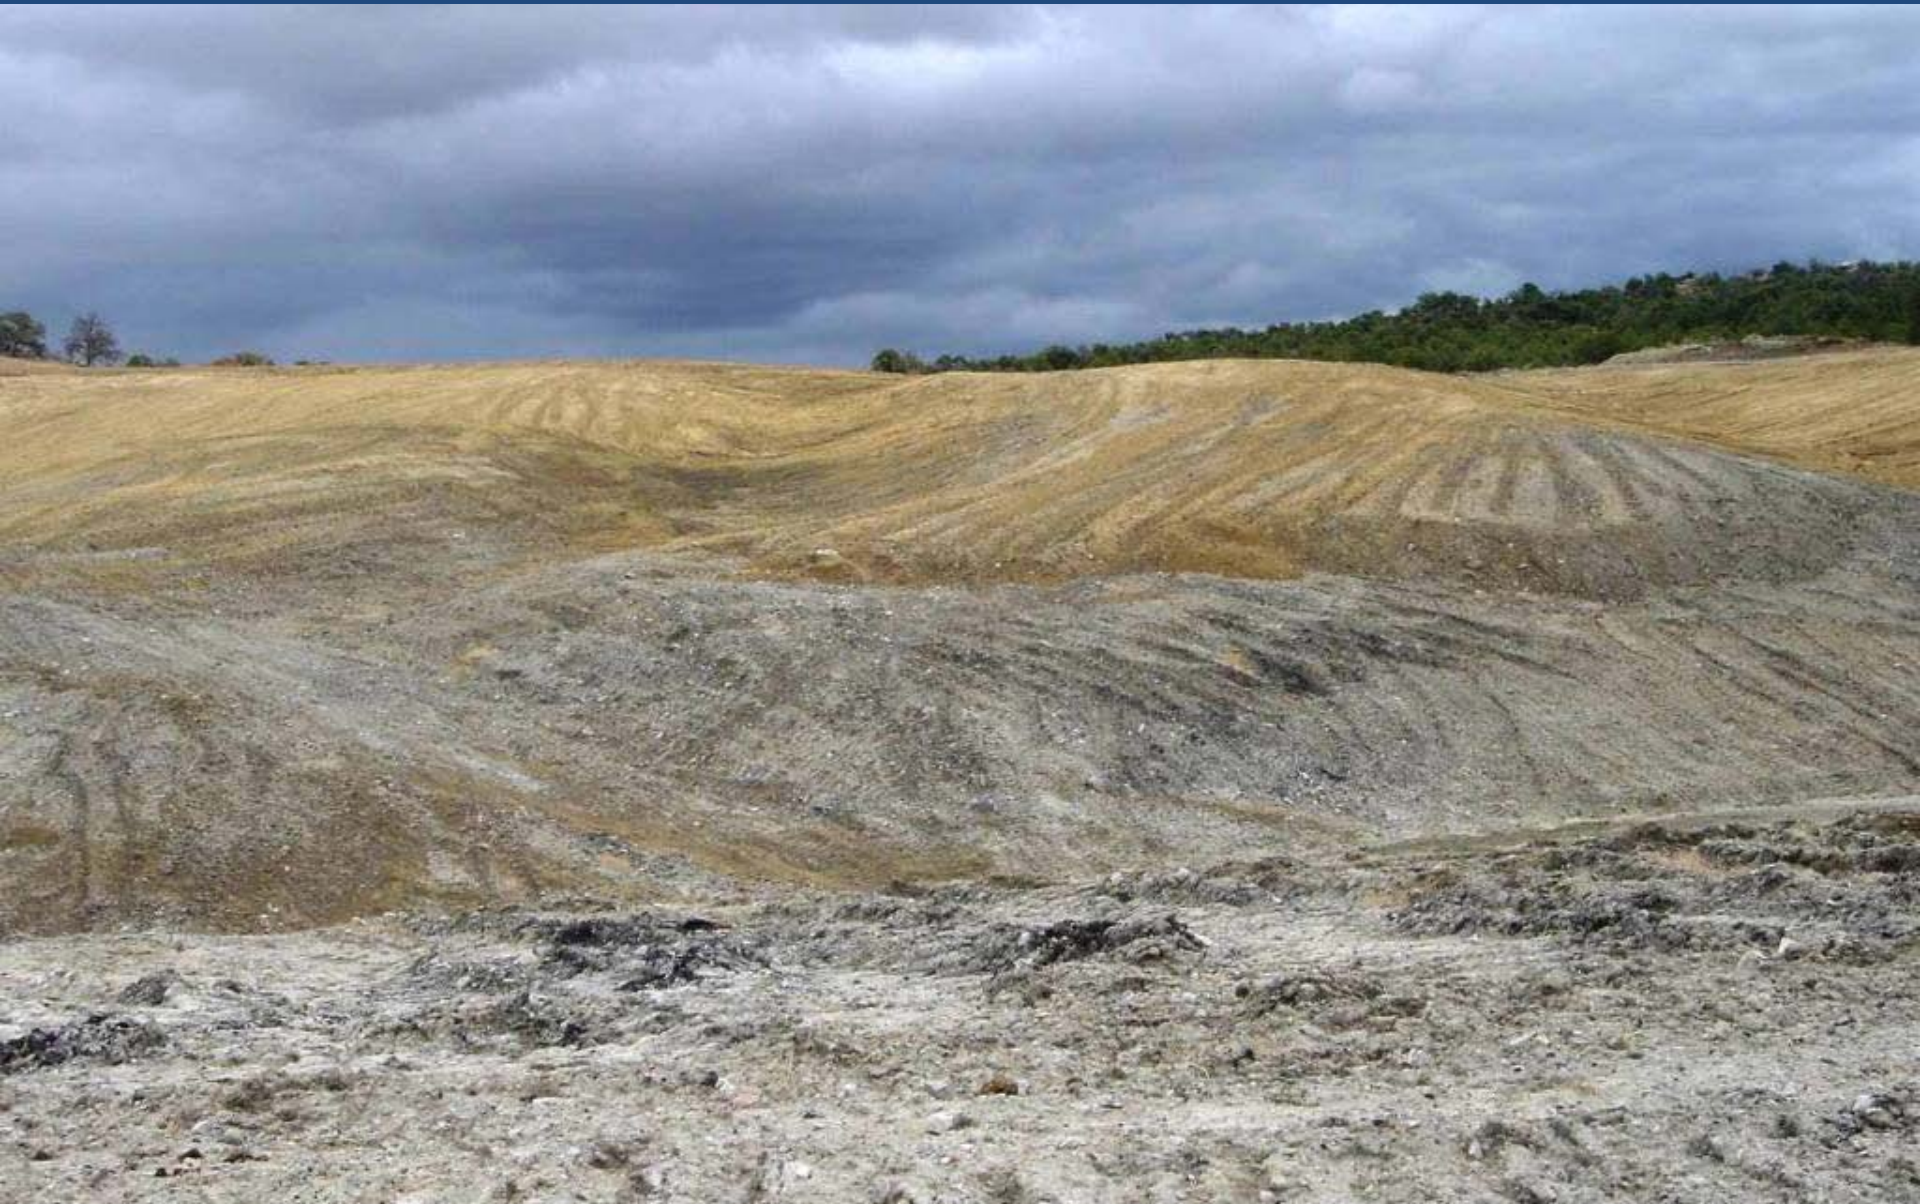
# Complex topography, Pit 10 highwall reclamation

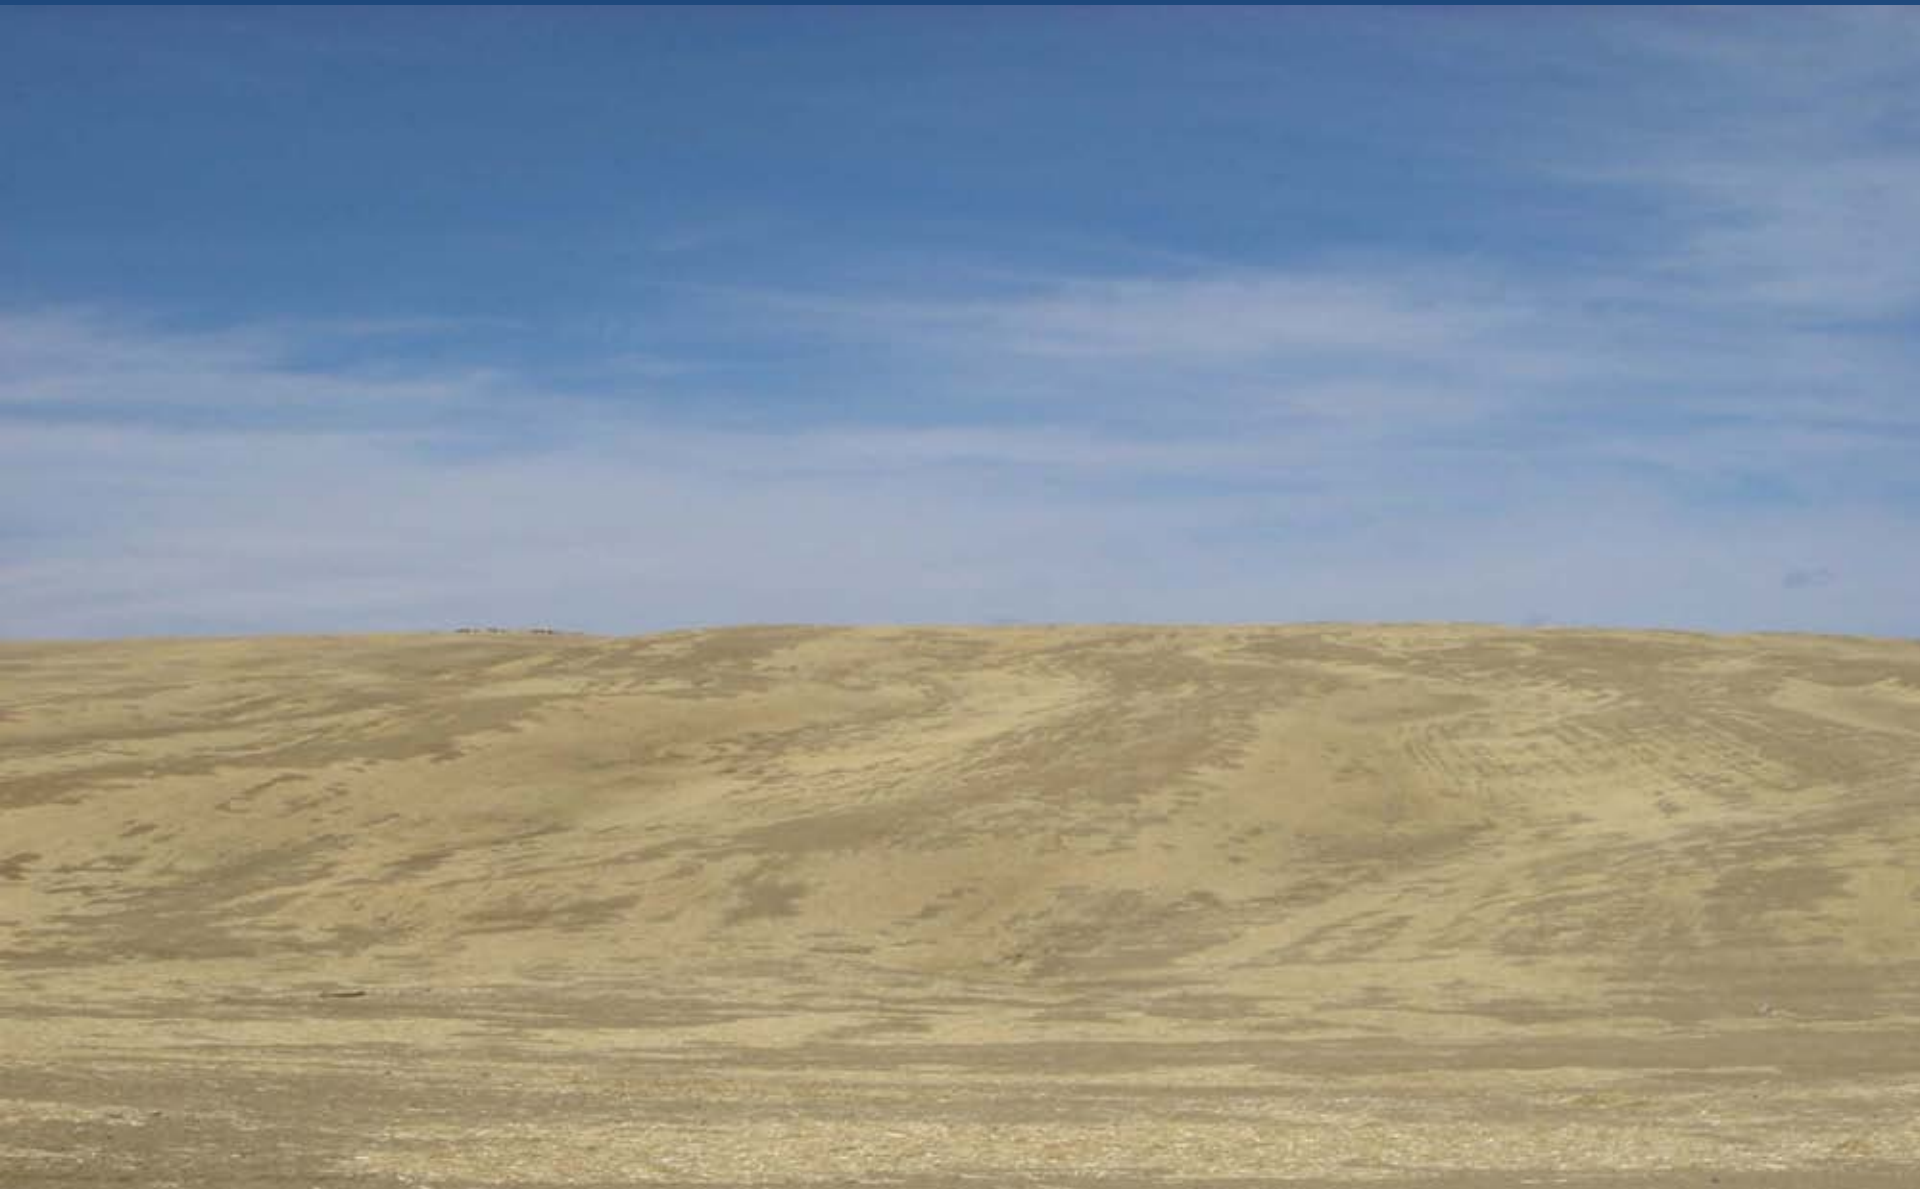
Ridges built by dumping excess spoil in windrows

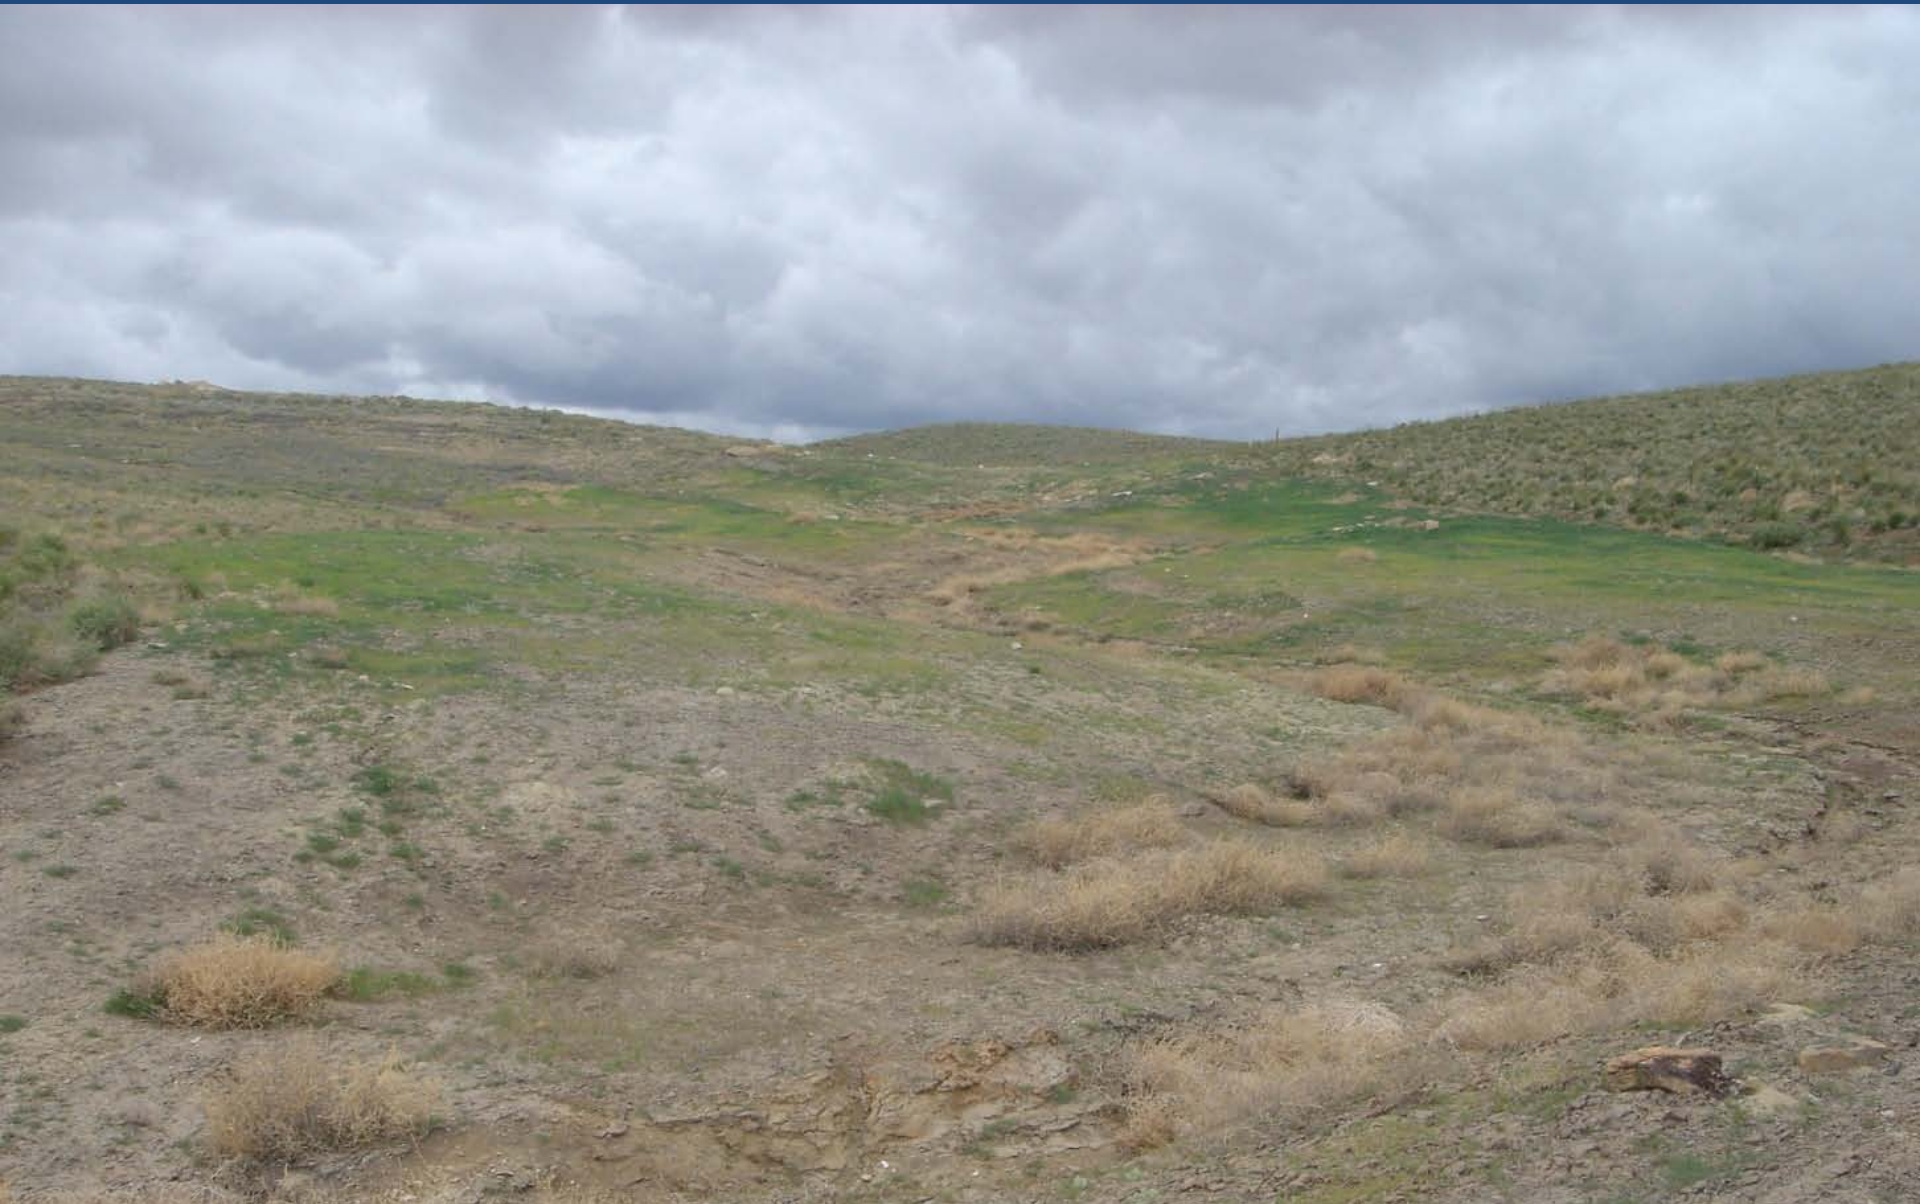
# Drainage channel constructed in a pit ramp

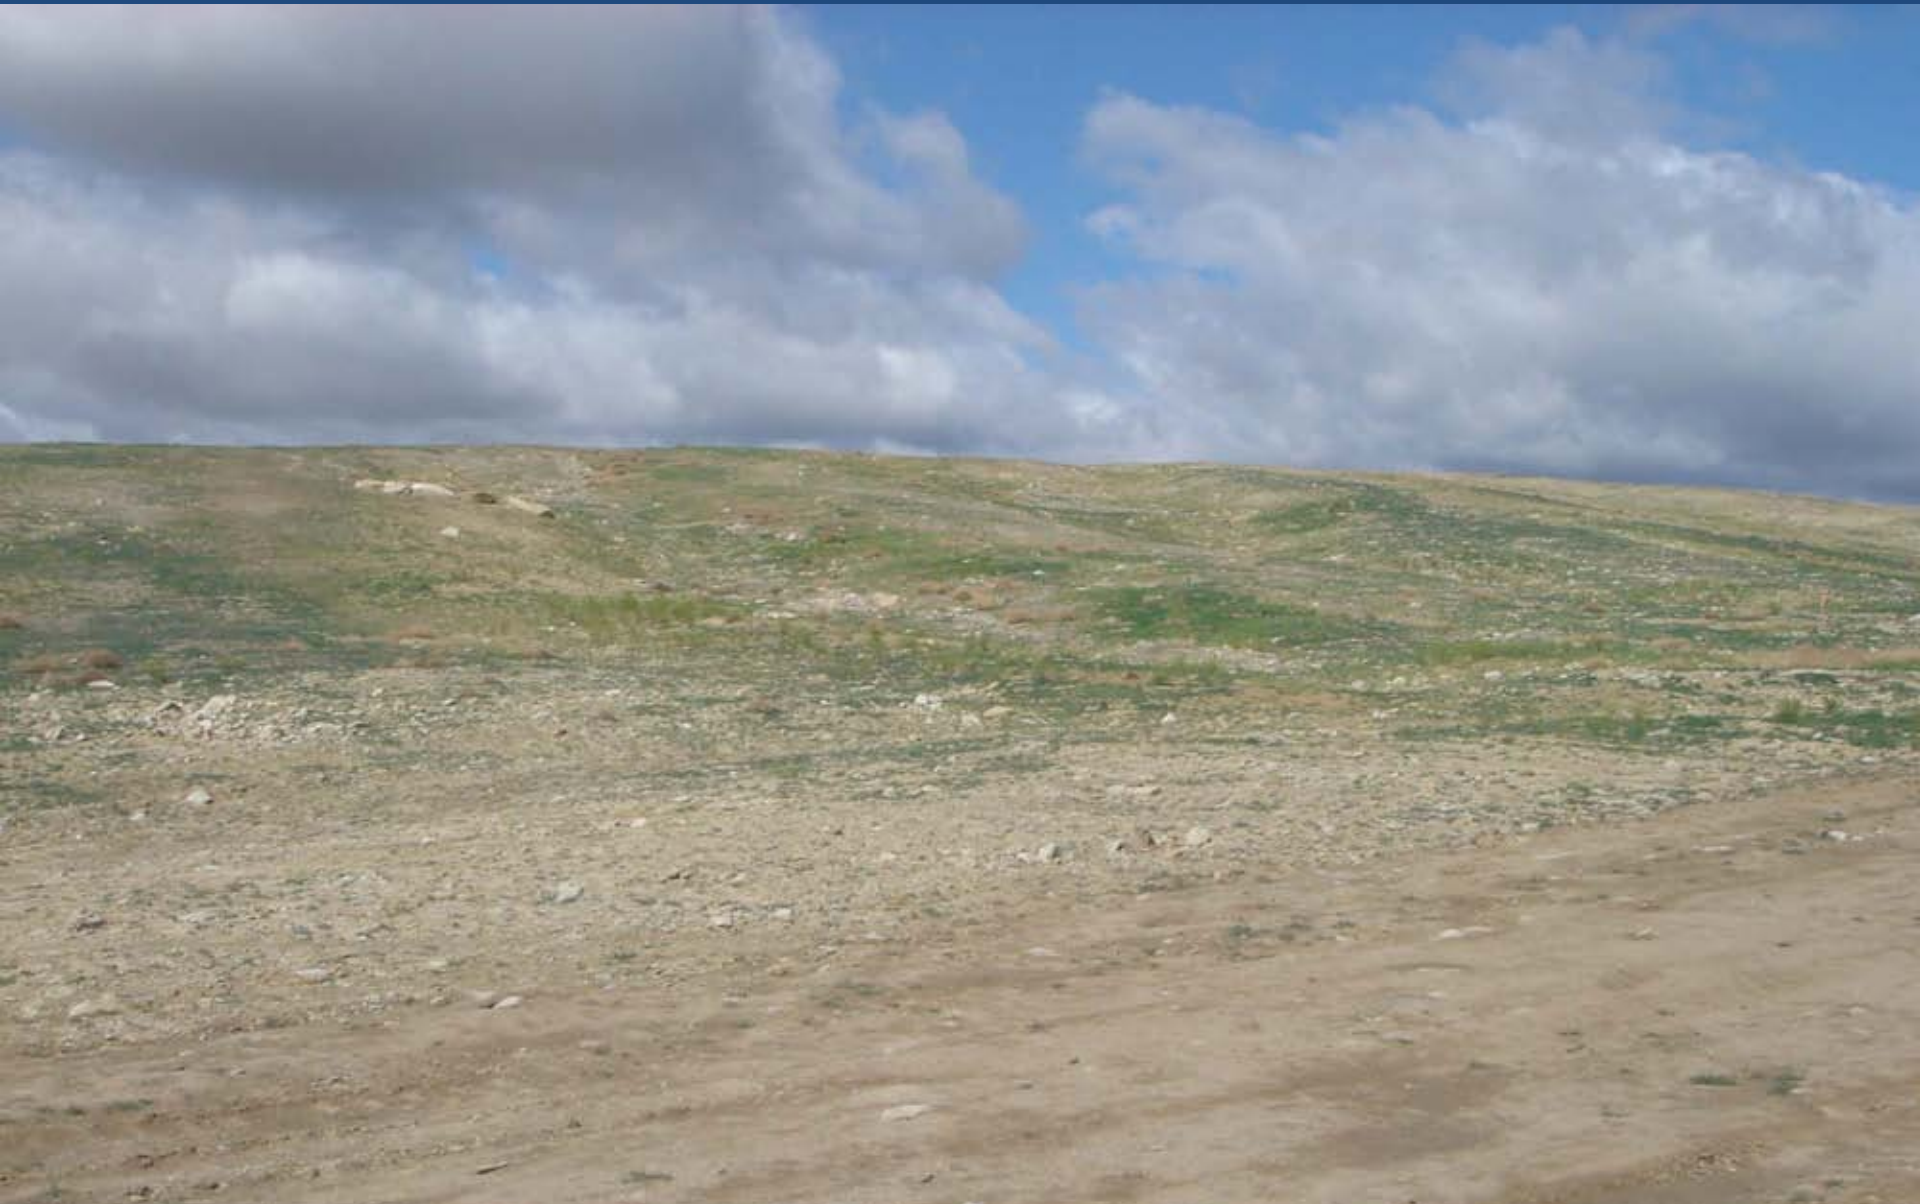
# Swales and soil substitute material on slopes
