# A Summary of Some Land Surface and Water Quality Monitoring Results for Constructed GeoFluv Landforms<sup>1</sup>

Nicholas Bugosh<sup>2</sup>

<sup>1</sup>Paper was presented at the 2009 National Meeting of the American Society of Mining and Reclamation, Billings, MT *Revitalizing the Environment: Proven Solutions and Innovative Approaches* May 30 – June 5, 2009. R.I. Barnhisel (Ed.) Published by ASMR, 3134 Montavesta Rd., Lexington, KY 40502.

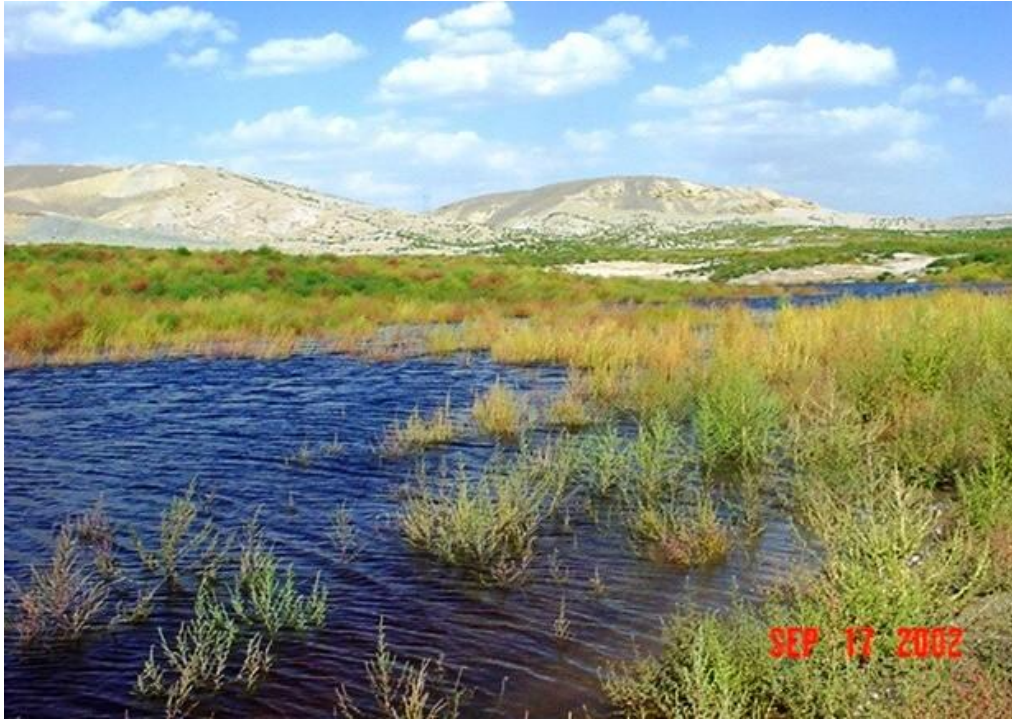
Figure 1. 17 Sept 2002, Cottonwood reclamation west storm surge basin as Inspector Robert Russell saw it. The un-vegetated portions of the two steep hills in the background are GeoFluv reclamation also and needed no erosion repair after the series of intense storms during the second week of September.

The fact that scuba divers had to be called in to the mine provides an image of the severity of the runoff. The effects of the storm caused many problems around the mine such as landslides 1.2 to 1.5 m (4 to 5 ft) deep covering a 0.4 km (0.25 mi) length of highway, cattle swept away in stream bottoms and never recovered, and the city of Farmington had to close the water treatment plant intake. The combination of high-intensity storms, thin soils, and sparse vegetation makes for rapid and great storm water discharges in this area. Despite all of these effects surrounding the mine, Inspector Russell noted that there were “No problems noted”. The view in Figure 1, taken six days after the series of intense storms, is from the western end of the west storm surge/infiltration basin looking across the Cottonwood reclamation to two of the steep reclamation slopes in the central part of the reclamation area. The minor erosion that he mentioned as “predicted in the design” was related to the plus-and-minus in the grading tolerances; this first storm discharge moved channel bed material from high spots to low spots and smoothed the channel bottom to design grade as verified by subsequent surveys. The landform’s performance at resisting erosion was part of the reason that the Cottonwood reclamation received two awards from the U.S. Department of the Interior/Office of Surface Mining in 2004; “National” and “Best of the Best” reclamation.

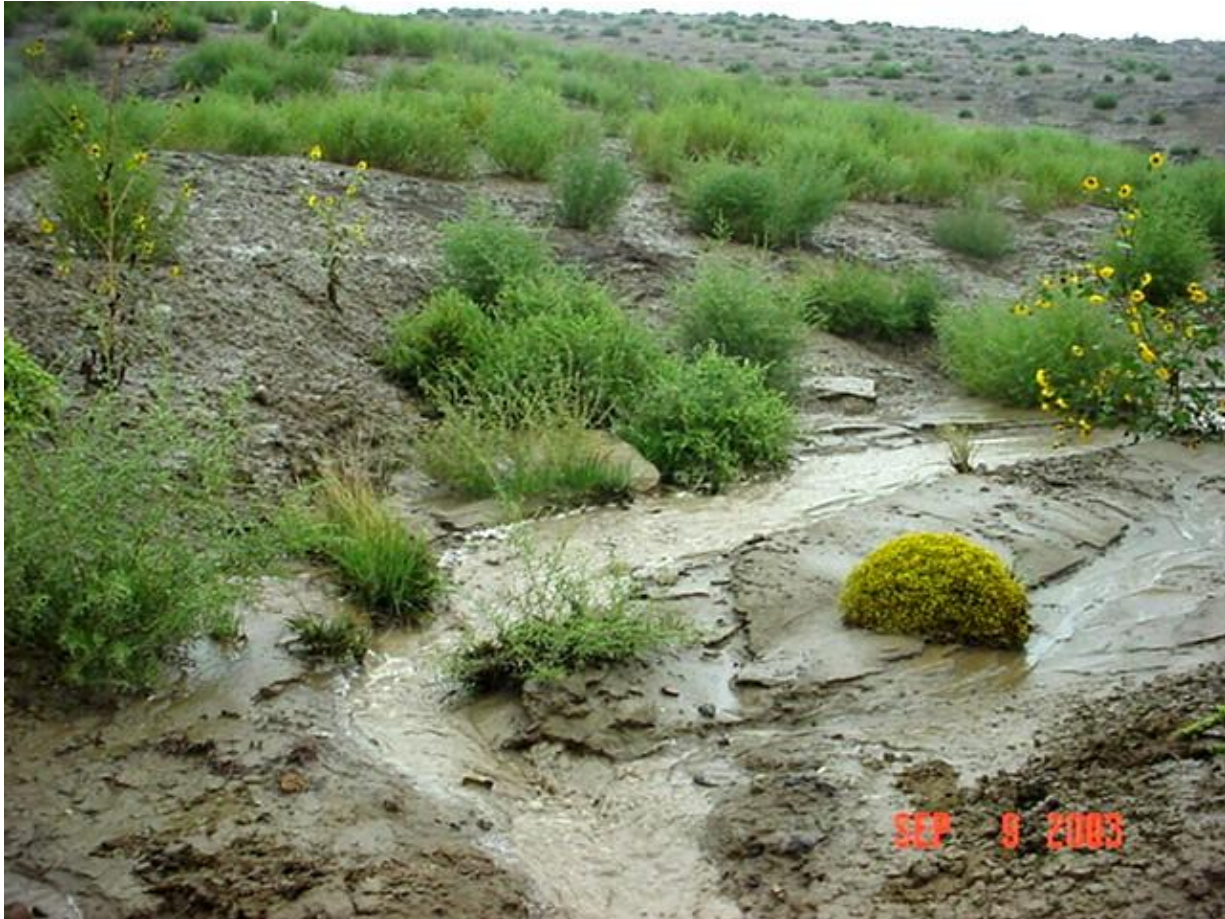
Figure 2. 9 September 2003, South McDermott channel, reach between tributaries 5 and 4, during waning discharge.

Figure 2 below shows a reach of the valley bottom channel on the south side of the reclaimed McDermott dump during waning discharge. The top of the rock at the center of the image is at bankfull depth and the stream is flowing in the channel. The stream is following the designed channel meander, but a portion of the flow has cut across the point bar as a result of the construction making the channel with-to-depth ratio greater than designed (as shown in Table 1 above for reaches 6, 7, and 8).

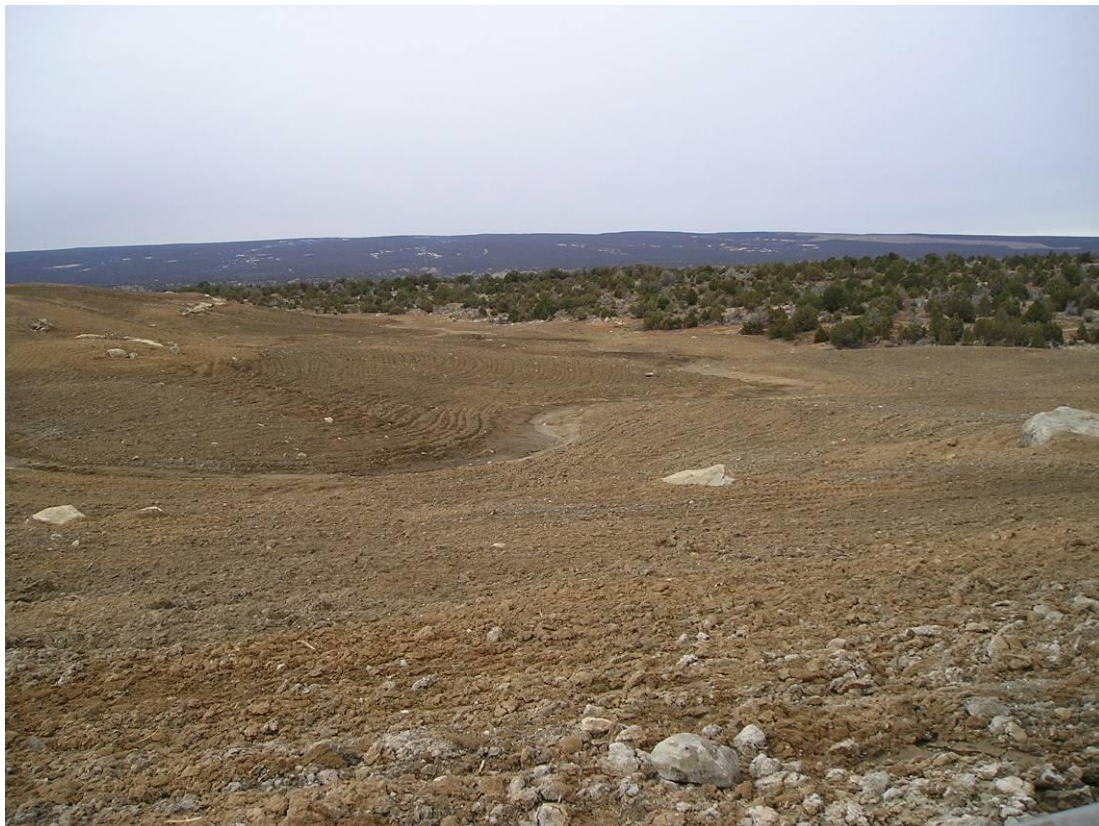
Figure 3. La Plata Mine Northgate North Subwatershed 1 in January 2005

Figure 3 below shows one of fourteen subwatersheds in the Northgate North project with spoil graded to design before topsoil application. The image above shows how Northgate North Subwatershed 1 was graded to a GeoFluv design before November of 2003. Close inspection will reveal construction equipment markings on the slopes, but there is no rilling or erosion. In the image, the landform has no topsoil, no vegetation, and no artificial erosion controls. The top of the ridge is 1,832 m (6,010 ft) elevation. The image was taken in January 2005, after the site endured the 2003/2004 snowmelts, 2004 monsoon rains, and the 2004/2005 snowmelts.

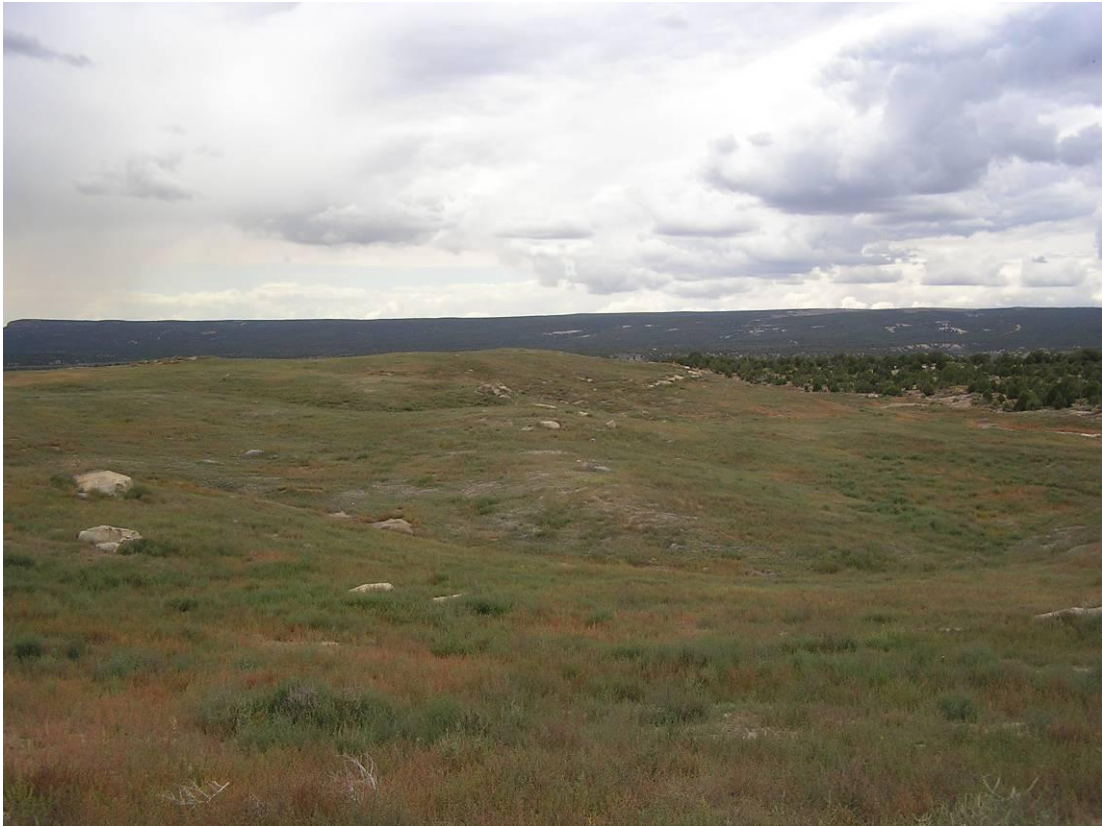
Figure 4. La Plata Mine Northgate North Subwatershed 1 in September 2006

The image in Figure 4 below was taken in mid-September of 2006 following the extreme July storm event. Figure 4 shows the same subwatershed as Figure 3 above after the application of topsoil and seeding, and is typical of the reclamation landform response to the >100-yr recurrence interval storm. The vegetation in the image is just starting and mostly annual plants are visible, representing just the first season's volunteer growth shading the reclamation seeding sprouts. The erosion monitoring after this extreme storm event documented that the fluvial geomorphic landform performed its functions as designed and found only two areas needing repair, at least one of which was attributable to improper construction.

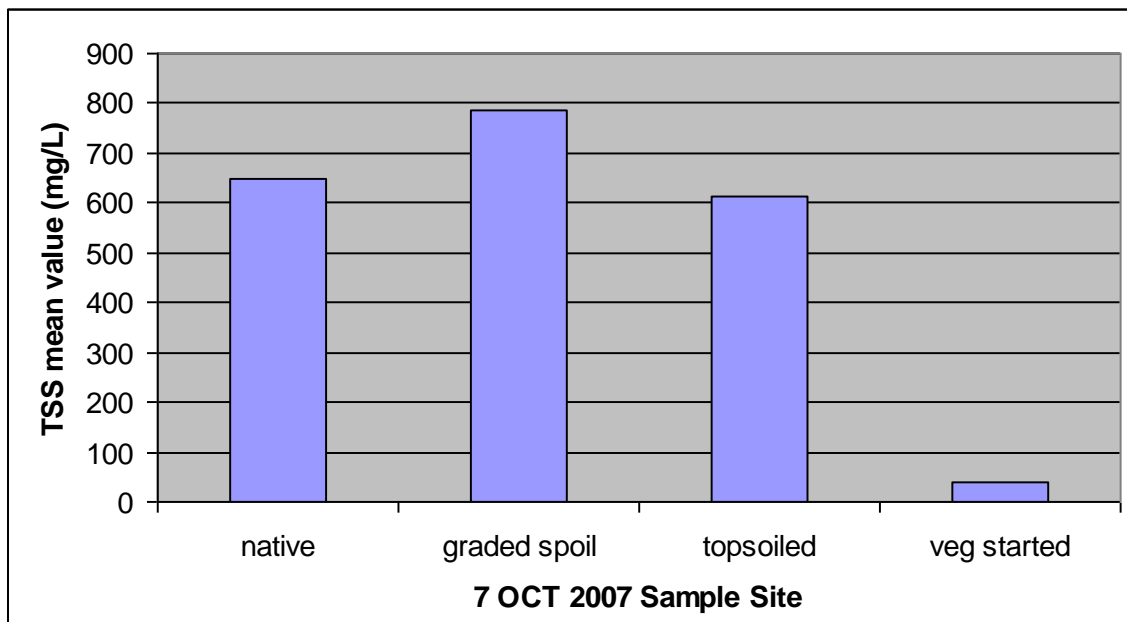
Figure 5. Graphic presentation of results of 7 October 2007 storm water sampling at La Plata Mine

Table 2 below lists total suspended solids (TSS) values for storm water samples collected within the reclamation area and for undisturbed areas outside of the reclamation. In the relatively narrow and shallow ephemeral channels of smaller upland watersheds, the usual sampling method is a grab samples taken with a wide-mouth bottle with the inlet restricted by the

These results strongly suggest that the geomorphic-designed landform with merely a topsoil cover can satisfy erosion control needs sufficient to meet water quality goals, but they do not tell the *soil volume or mass* that was involved. Although the water quality samples from La Plata Mine give some indication of the erosion control benefit of this geomorphic approach, they do not directly quantify actual sediment load (volume). The concentration values, without discharge and duration data, and supplemental concentration values taken throughout the event, cannot quantify the actual amount of erosion associated with the storm event. Nonetheless, the ‘topsoiled’ and ‘re-vegetated’ samples total suspended solids concentrations were an order of magnitude lower than the ‘native’ sample and three orders of magnitude lower than the native McDermott Arroyo. A research grant has been proposed to OSM to quantify the actual erosion rate associated with the GeoFluv landform and can provide valuable data to future reclamation designers and regulatory oversight staff.

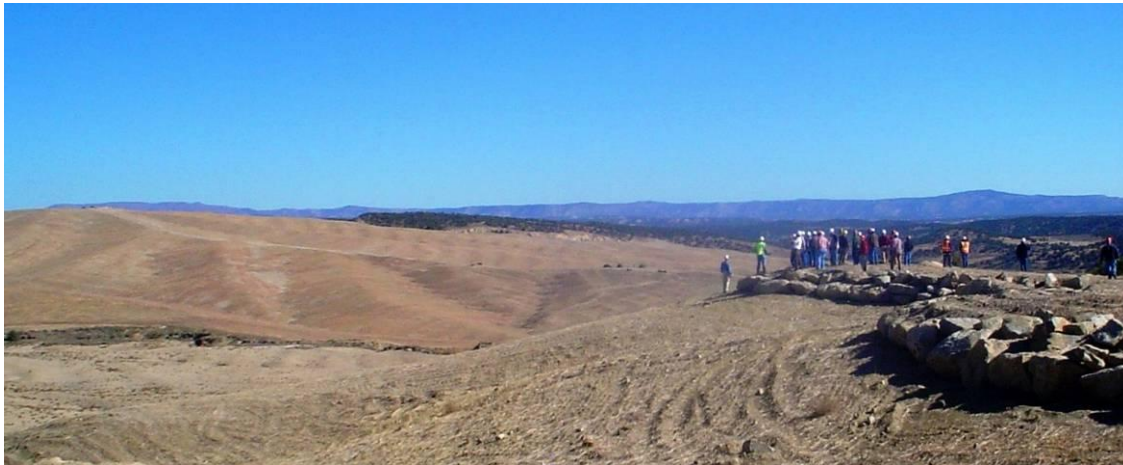
Figure 6. A fluvial geomorphic reclamation area at La Plata Mine that has been topsoiled; all the landform in the fore-ground and mid-ground without tree cover is graded and topsoiled reclamation. Image captured during 28 October 2008 National Association of Abandoned Mine Land Programs national conference tour.

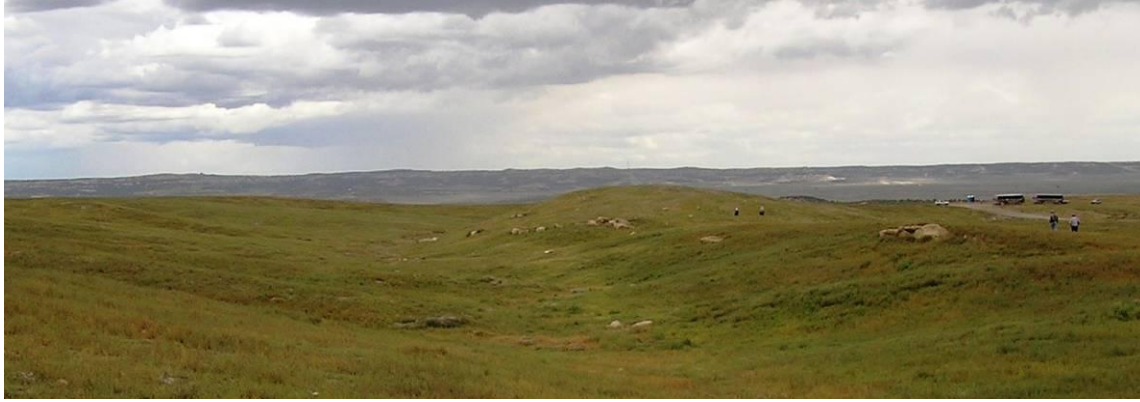
Figure 7. A view of a fluvial geomorphic reclamation area at La Plata Mine that has vegetation starting. The image of a subwatershed headwaters area was captured during the 12 September 2006 National Interactive Forum on Geomorphic Reclamation. The vegetation in the image is just starting and mostly annual plants are visible, representing just the first season's volunteer growth shading the reclamation seeding sprouts.

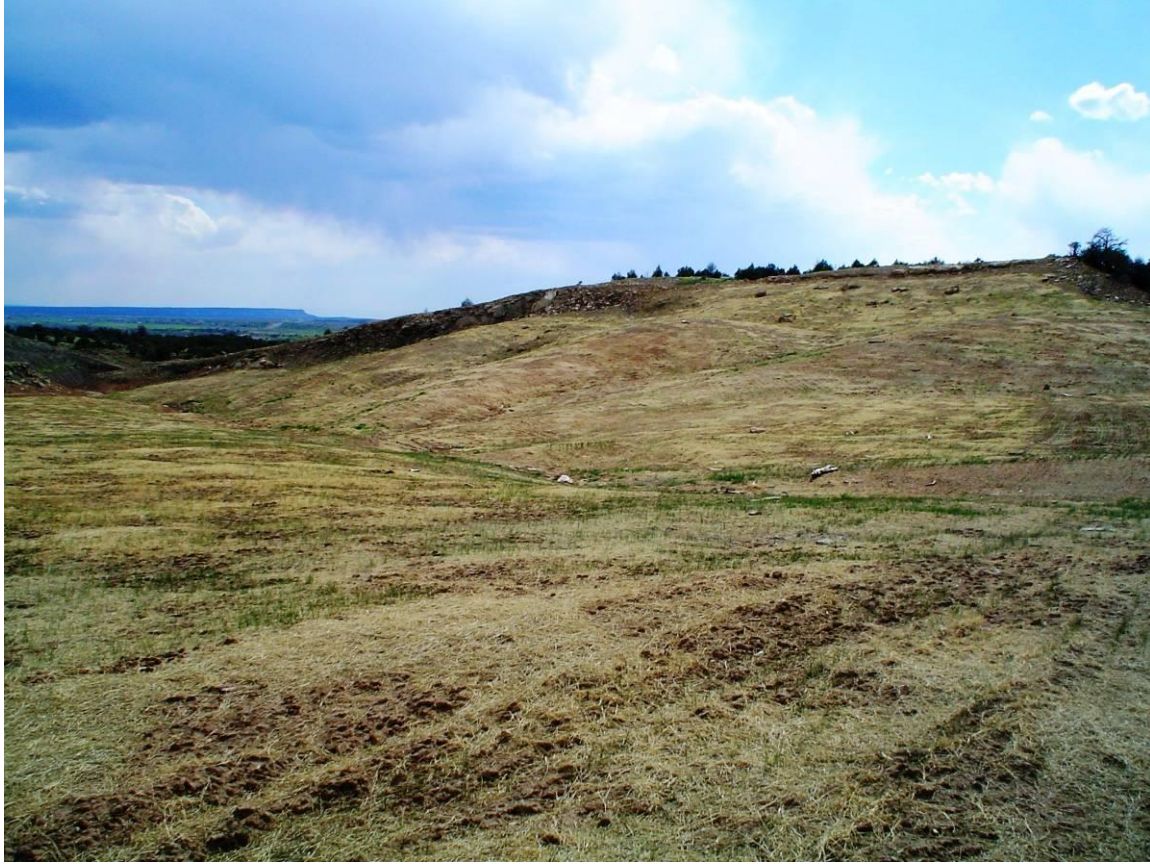
Figure 8. 5 May 2005, 170 Arroyo endwall reclamation with grassland mixture sprouting

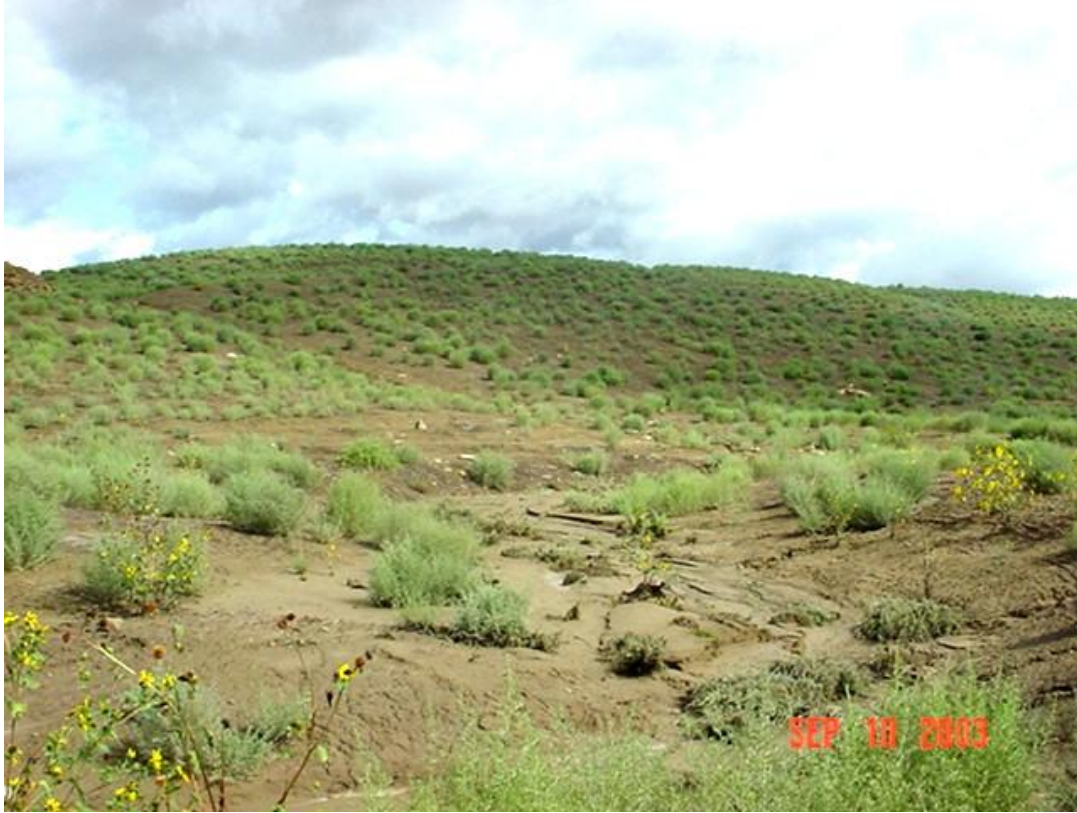
Figure 9. 10 September 2003, South McDermott valley bottom channel, reach 7 to 8

The vegetation monitoring to date suggests that varying the seeding rates of the same species from one mixture to another is too subtle a difference to create discrete communities. Figure 9 below shows a portion of the south face of the McDermott reclamation with the lower reaches of its valley bottom stream channel the day following a 50-yr, 4-hr discharge event. The forbes are Four-wing Saltbush that were seeded as part of the plant mixes described above. The Saltbush grew vigorously, whereas the grasses were slower to sprout, but eventually did in the cooler, shadier areas around the base of the Saltbush. Also, note that the channel bottom is relatively free of vegetation and the bent-over vegetation on the channel's point bar shows the flood prone area designed into the channel cross section.

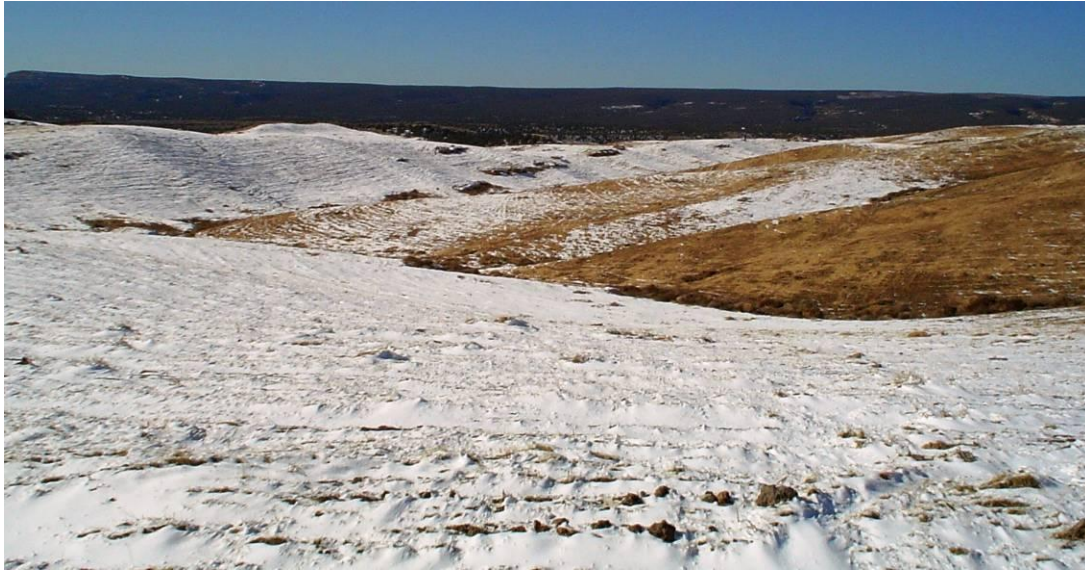
Figure 10. December 2005, Northgate Arroyo headwaters showing variation in moisture harvesting from slope aspect diversity in fluvial geomorphic-designed landform.

Conversely, the variation in moisture harvest resulting from the dissected topography will likely play a larger role in creating community diversity. The image in Figure 10 below was taken in December 2005 and shows the variation in moisture harvesting that results from the complex fluvial geomorphic slope design. The north-facing slope at the left of the image is maximizing moisture harvesting because it is not exposed to the sun's energy all day. The south-facing slope across the valley has less snow cover overall, but the GeoFluv design has broken the slope into smaller subwatersheds that contain east and west aspects. The reclamation landform provides variation in water content and sunlight to naturally create niches for different plant species that will promote vegetation diversity.
